Access Compliance Report

Public Rights-of-Way (Curb Ramps)

Intersection ID: 4539	Main Street: CRAVEN_HILL_DR	Cross Street: KARA_DR	Location:	N
ADA ID: 5AE257C18714	Ramp Type: Perp	Initial Pass/Fail: Fail	Overall Compliance: No	Severity Score: 35

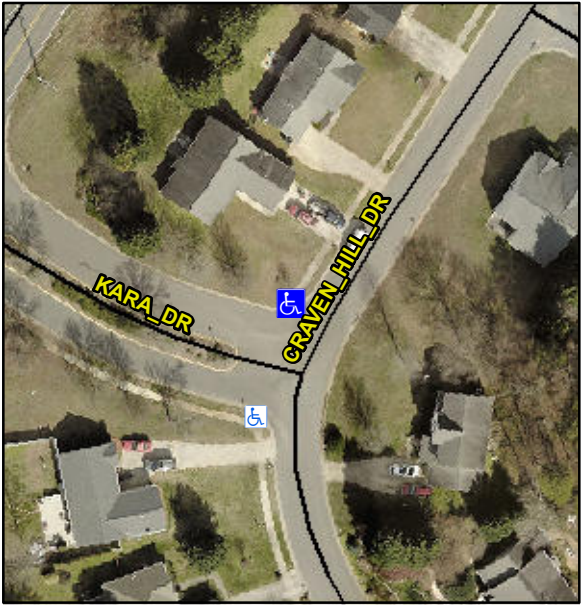
Possible Solutions:		Compliance	Description	Data
	Remove & Replace Entire Ramp.		N/A	Ramp Length (in)	60.0
			No	Ramp Width (in)	30.0
			N/A	Flare Type LT	N/A
			N/A	Flare Slope LT (%)	N/A
			N/A	Flare Traversable LT?	N/A
			N/A	Landing Length (in)	N/A
			N/A	Landing Width (in)	N/A
			N/A	Landing Slope (%)	N/A
			N/A	Landing X Slope (%)	N/A
<p>Surveyor Notes:</p> <p>N/A</p> <p>PROW/ADA:</p> <p>Not Found, R304.5.1</p>			N/A	Flare Type RT	N/A
			N/A	Flare Slope RT (%)	N/A
			N/A	Flare Traversable RT?	N/A
			N/A	DWS Provided?	N/A
			N/A	DWS Contrast?	N/A
			N/A	DWS Length (in)	N/A
			N/A	DWS Full Width?	N/A
			N/A	DWS Offset (in)	N/A
			N/A	Shared Landing?	N/A
			N/A	Gutter Ponding?	N/A
			N/A	Gutter Lip Ht (in)	N/A
			N/A	Painted X Walk1?	No
				X Walk 1 Direction	To SW
			N/A	X Walk 1 Width (in)	N/A
				X Walk 1 Slope (%)	0.3
				X Walk 1 X Slope (%)	1.1

N/A	Ramp inside XWalk1?	N/A
			N/A	Road Slope (%)	N/A
			N/A	Road X Slope (%)	N/A
			N/A	Any Obstructions?	N/A
				Obstruction Type	
			N/A		
			N/A		
			N/A		
			N/A		
			N/A		
			N/A		
			N/A		
			N/A		
			N/A		
Total Cost:		\$ 1850.00			
			N/A		
			Yes	Surface Condition? (G/P)	Good
