Access Compliance Report

Public Rights-of-Way

(Curb Ramps)

Intersection ID: N/A	Main Street: INVERNESS_BAY_RD	Cross Street: OBAN_PASSAGE_DR	Location: NE
ADA ID: 5AE35F2D01C8	Ramp Type: Perp	Initial Pass/Fail: Fail	Overall Compliance: No
Codes/Mitigation Info/Possible Solution		Field Measurements/Component Compliance	
Severity Score: 21.25

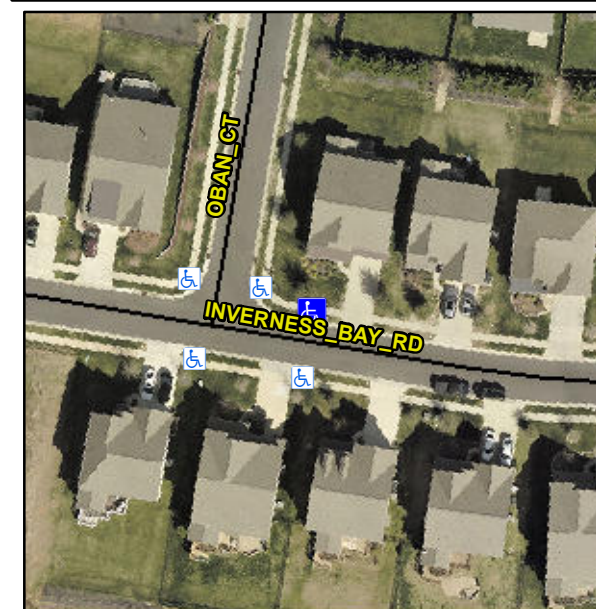
Not Found, R304.5.1, R304.5.3

Compliance	Description	Data	Compliance	Description	Data
N/A	Ramp Length (in)	44.5	Yes	Ramp Slope (%)	7.7
No	Ramp Width (in)	47.5	No	Ramp XSlope (%)	5.6
N/A	Flare Type LT	N/A	N/A	Flare Type RT	N/A
N/A	Flare Slope LT (%)	N/A	N/A	Flare Slope RT (%)	N/A
N/A	Flare Traversable LT?	N/A	N/A	Flare Traversable RT?	N/A
N/A	Landing Length (in)	N/A	N/A	DWS Provided?	N/A
N/A	Landing Width (in)	N/A	N/A	DWS Contrast?	N/A
N/A	Landing Slope (%)	N/A	N/A	DWS Length (in)	N/A
N/A	Landing X Slope (%)	N/A	N/A	DWS Full Width?	N/A
N/A	Landing Curb? (Y/N)	N/A	N/A	DWS Offset (in)	N/A
N/A	Shared Landing?	N/A			
N/A	Gutter Ponding?	N/A	N/A	Gutter Slope (%)	N/A
N/A	Gutter Lip Ht (in)	1.0	N/A	Gutter X Slope (%)	N/A
N/A	Painted X Walk1?	No	N/A	Painted X Walk2?	N/A
	X Walk 1 Direction	To SW		X Walk 2 Direction	N/A
N/A	X Walk 1 Width (in)	N/A	N/A	X Walk 2 Width (in)	N/A
	X Walk 1 Slope (%)	3.8		X Walk 2 Slope (%)	N/A
	X Walk 1 X Slope (%)	4.5		X Walk 2 X Slope (%)	N/A

N/A	Ramp inside XWalk1?	N/A	N/A	Ramp inside XWalk2?	N/A
	Road Slope (%)	N/A	N/A	Clear Space?	N/A
	Road X Slope (%)	N/A	N/A	Clear Space to XWalk (in)	N/A
N/A	Any Obstructions?	N/A	N/A	Storm Grate/Utility Hazard?	N/A
	Obstruction Type			Storm Grate/Utility Type	
		N/A			N/A
			Yes	Surface Condition? (G/P)	Good

Possible Solutions:

Remove & Replace Entire Ramp.

Total Cost: \$ 1850.00
