# Access Compliance Report

## Public Rights-of-Way

### (Curb Ramps)

Intersection ID: N/A	Main Street: SHARON_RIDGE_LN	Cross Street: N/A	Location: S
ADA ID: 5B09740707FB	Ramp Type: Perp	Initial Pass/Fail: Fail	Overall Compliance: No
Severity Score: 12.5			
Codes/Mitigation Info/Possible Solution		Field Measurements/Component Compliance

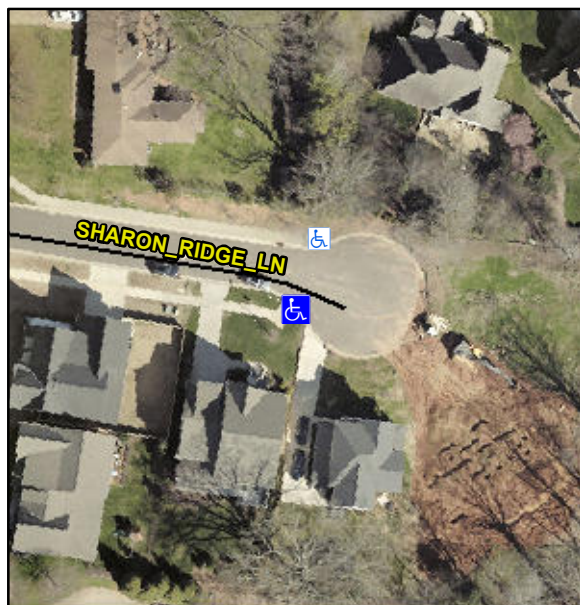
PROW/ADA:

**Not Found, R304.5.3**

Compliance	Description	Data	Compliance	Description	Data
N/A	Ramp Length (in)	93.0	Yes	Ramp Slope (%)	7.5
Yes	Ramp Width (in)	48.0	No	Ramp XSlope (%)	6.9
N/A	Flare Type LT	N/A	N/A	Flare Type RT	N/A
N/A	Flare Slope LT (%)	N/A	N/A	Flare Slope RT (%)	N/A
N/A	Flare Traversable LT?	N/A	N/A	Flare Traversable RT?	N/A
N/A	Landing Length (in)	N/A	N/A	DWS Provided?	N/A
N/A	Landing Width (in)	N/A	N/A	DWS Contrast?	N/A
N/A	Landing Slope (%)	N/A	N/A	DWS Length (in)	N/A
N/A	Landing X Slope (%)	N/A	N/A	DWS Full Width?	N/A
N/A	Landing Curb? (Y/N)	N/A	N/A	DWS Offset (in)	N/A
N/A	Shared Landing?	N/A			
N/A	Gutter Ponding?	N/A	N/A	Gutter Slope (%)	N/A
N/A	Gutter Lip Ht (in)	N/A	N/A	Gutter X Slope (%)	N/A
N/A	Painted X Walk1?	No	N/A	Painted X Walk2?	N/A
	X Walk 1 Direction	To N		X Walk 2 Direction	N/A
N/A	X Walk 1 Width (in)	N/A	N/A	X Walk 2 Width (in)	N/A
	X Walk 1 Slope (%)	0.8		X Walk 2 Slope (%)	N/A
	X Walk 1 X Slope (%)	8.0		X Walk 2 X Slope (%)	N/A

Possible Solutions:

**Remove & Replace Entire Ramp.**

Total Cost: \$ 1850.00

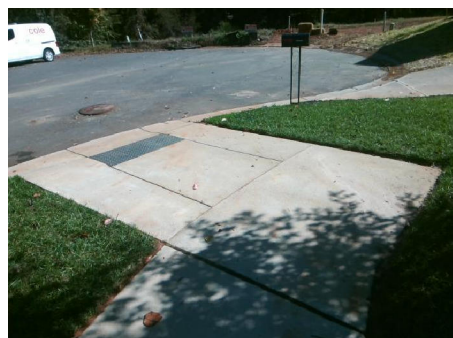
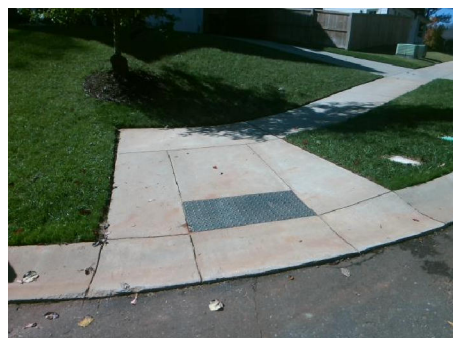
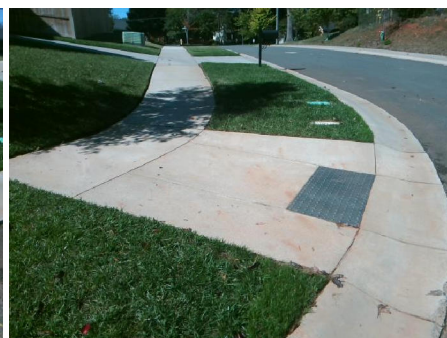
N/A	Ramp inside XWalk1?	N/A	N/A	Ramp inside XWalk2?	N/A
	Road Slope (%)	N/A	N/A	Clear Space?	N/A
	Road X Slope (%)	N/A	N/A	Clear Space to XWalk (in)	N/A
N/A	Any Obstructions?	N/A	N/A	Storm Grate/Utility Hazard?	N/A
	Obstruction Type			Storm Grate/Utility Type	
		N/A			N/A
			Yes	Surface Condition? (G/P)	Good
