## Access Compliance Report Public Rights-of-Way (Curb Ramps)

Intersection ID: 21433	21433 Main Street: PARK_RD					Location:	NW		
			Cross Street: SPRING_VALLEY_RD						
ADA ID: 5B0EDC161A30 Ramp Type: PerpDiag		Initial Pass/Fail: Fail Overall Compliance: N				Severity Score:	21.25		
Codes/Mitigation Info/Possible Solution				Field Measurements/Component Compliance					
	6	Possible Solutions:		Compliance Description		Data	Data Compliance Description		Data
SPRING WILLIAM RD		Remove & Replace Curb Ramp W	/ith	N/A	Ramp Length (in)	57.0	No	Ramp Slope (%)	9.6
		Two New Directional Ramps or		No	Ramp Width (in)	42.0	Yes	Ramp XSlope (%)	1.4
		Equivalent.		N/A	Flare Type LT	N/A	N/A	Flare Type RT	N/A
				N/A	Flare Slope LT (%)	N/A	N/A	Flare Slope RT (%)	N/A
				N/A	Flare Traversable LT?	N/A	N/A	Flare Traversable RT?	N/A
				N/A	Landing Length (in)	N/A	N/A	DWS Provided?	N/A
		Surveyor Notes:		N/A	Landing Width (in)	N/A	N/A	DWS Contrast?	N/A
		N/A		N/A	Landing Slope (%)	N/A	N/A	DWS Length (in)	N/A

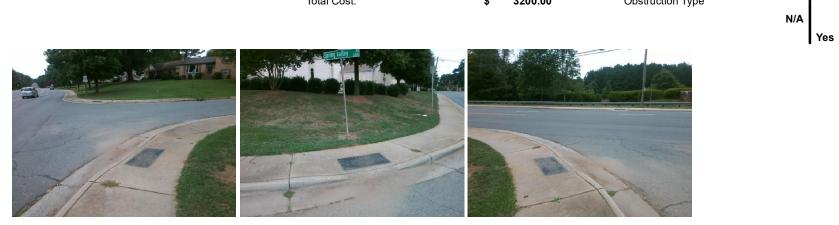
N/A	Landing X Slope (%)	N/A	N/A	DWS Full Width?	N/A
the second				N/A	Landing Curb? (Y/N)	N/A	N/A	DWS Offset (in)	N/A
				N/A	Shared Landing?	N/A			
	F 1	PROW/ADA:		N/A	Gutter Ponding?	Yes	N/A	Gutter Slope (%)	N/A
A Star		Not Found, R304.5.1, R304.2.2		N/A	Gutter Lip Ht (in)	N/A	N/A	Gutter X Slope (%)	N/A
		·····, ·····, ······, ······		N/A	Painted X Walk1?	No	N/A	Painted X Walk2?	No
					X Walk 1 Direction	To SW		X Walk 2 Direction	To SE
				N/A	X Walk 1 Width (in)	N/A	N/A	X Walk 2 Width (in)	N/A
Street 1 Name SPRING	VALLEY RD				X Walk 1 Slope (%)	0.6		X Walk 2 Slope (%)	0.4
Stop Condition-Street 2	StopSign				X Walk 1 X Slope (%)	1.0		X Walk 2 X Slope (%)	1.2
Street 2 Name	PARK RD			N/A	Ramp inside XWalk1?	N/A	N/A	Ramp inside XWalk2?	N/A
Stop Condition-Street 1	None				Road Slope (%)	0.2	N/A	Clear Space?	N/A
					Road X Slope (%)	0.4	N/A	Clear Space to XWalk (in)	N/A
				N/A	Any Obstructions?	N/A	N/A	Storm Grate/Utility Hazard?	N/A
