Access Compliance Report

Public Rights-of-Way

(Curb Ramps)

Intersection ID: 46470	Main Street: CRANDON_DR	Cross Street: PEACH_BUD_LN	Location: SW
ADA ID: 5B1015490060	Ramp Type: PerpDiag	Initial Pass/Fail: Fail	Overall Compliance: No
		Severity Score: 15

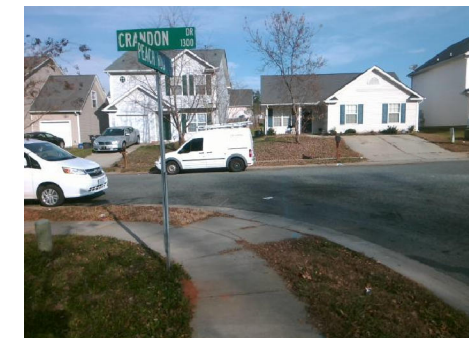
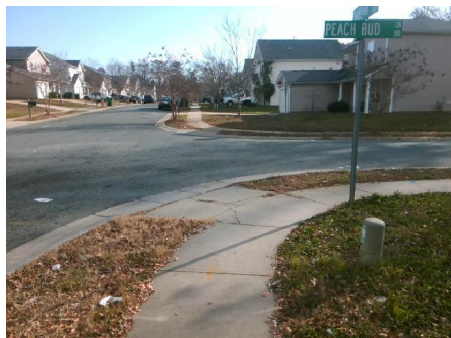
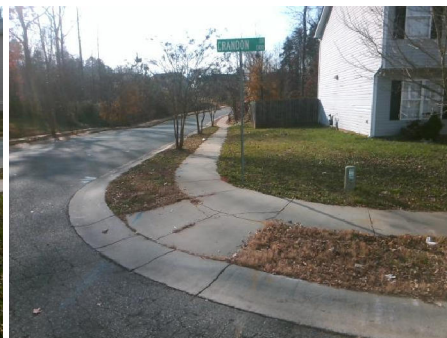
Compliance	Description	Data	Compliance	Description	Data
N/A	Ramp Length (in)	48.0	Yes	Ramp Slope (%)	8.0
Yes	Ramp Width (in)	48.0	Yes	Ramp XSlope (%)	1.6
N/A	Flare Type LT	N/A	N/A	Flare Type RT	N/A
N/A	Flare Slope LT (%)	N/A	N/A	Flare Slope RT (%)	N/A
N/A	Flare Traversable LT?	N/A	N/A	Flare Traversable RT?	N/A
N/A	Landing Length (in)	N/A	N/A	DWS Provided?	N/A
N/A	Landing Width (in)	N/A	N/A	DWS Contrast?	N/A
N/A	Landing Slope (%)	N/A	N/A	DWS Length (in)	N/A
N/A	Landing X Slope (%)	N/A	N/A	DWS Full Width?	N/A
N/A	Landing Curb? (Y/N)	N/A	N/A	DWS Offset (in)	N/A
N/A	Shared Landing?	N/A			
N/A	Gutter Ponding?	N/A	N/A	Gutter Slope (%)	N/A
N/A	Gutter Lip Ht (in)	1.5	N/A	Gutter X Slope (%)	N/A
N/A	Painted X Walk1?	No	N/A	Painted X Walk2?	No
	X Walk 1 Direction	To E		X Walk 2 Direction	To N
N/A	X Walk 1 Width (in)	N/A	N/A	X Walk 2 Width (in)	N/A
	X Walk 1 Slope (%)	1.3		X Walk 2 Slope (%)	2.3
	X Walk 1 X Slope (%)	1.7		X Walk 2 X Slope (%)	2.9

N/A	Ramp inside XWalk1?	N/A	N/A	Ramp inside XWalk2?	N/A
	Road Slope (%)	3.0	N/A	Clear Space?	N/A
	Road X Slope (%)	4.7	N/A	Clear Space to XWalk (in)	N/A
N/A	Any Obstructions?	N/A	N/A	Storm Grate/Utility Hazard?	N/A
	Obstruction Type			Storm Grate/Utility Type	
		N/A			N/A
		No		Surface Condition? (G/P)	Poor

Remove & Replace Curb Ramp With Two New Directional Ramps or Equivalent.
