# Access Compliance Report

## Public Rights-of-Way

| Intersection ID: 28386 | Main Street: MARVIN_RD | Cross Street: SOUTHAMPTON_COMMONS_DR | Location: S |
| ADA ID: 5B1330BD10C8 | Ramp Type: PerpDiag | Initial Pass/Fail: Fail | Overall Compliance: No |

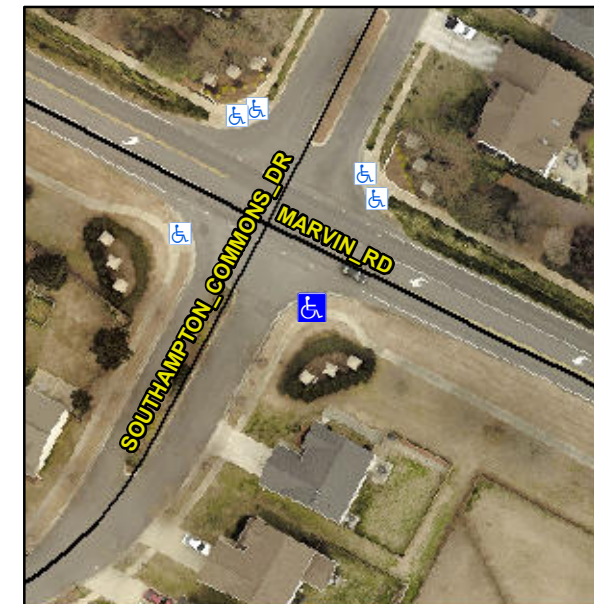
| | | Severity Score: 30 | |

**R304.5.1, R304.5.3**

| Compliance | Description | Data | Compliance | Description | Data |
|---|---|---|---|---|---|
| N/A | Ramp Length (in) | 71.0 | Yes | Ramp Slope (%) | 7.5 |
| No | Ramp Width (in) | 35.0 | No | Ramp XSlope (%) | 5.1 |

**Remove & Replace Curb Ramp With Two New Directional Ramps or Equivalent.**

Total Cost: \$ 3200.00
