Access Compliance Report

Public Rights-of-Way

(Curb Ramps)

| Intersection ID: 17176 | Main Street: BURNTWOOD_CT | Cross Street: MISSION_HILLS_RD | Location: NW |

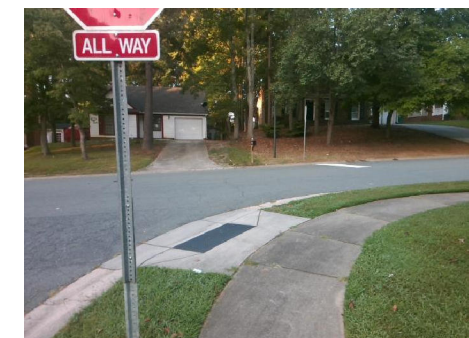
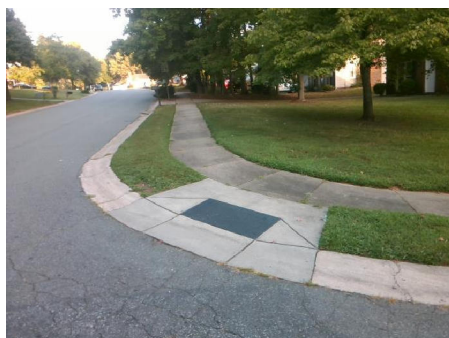
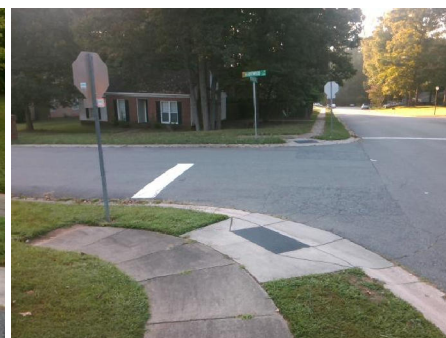
| ADA ID: 5B1AC443B35D | Ramp Type: PerpDiag | Initial Pass/Fail: Fail | Overall Compliance: No |
| Severity Score: 37.5 | | | |

Not Found, R304.2.2, R304.5.3

| Compliance | Description | Data | Compliance | Description | Data |
|---|---|---|---|---|---|
| N/A | Ramp Length (in) | 48.0 | No | Ramp Slope (%) | 8.6 |
| Yes | Ramp Width (in) | 48.0 | No | Ramp XSlope (%) | 11.9 |

Remove & Replace Curb Ramp With Two New Directional Ramps or Equivalent.

Total Cost: \$ 3200.00
