Access Compliance Report

Public Rights-of-Way

(Curb Ramps)

Intersection ID: 51510	Main Street: KENILWORTH_AV	Cross Street: PEARL_PARK_WY	Location: SW
ADA ID: 5B210BE069EF	Ramp Type: Perp	Initial Pass/Fail: Fail	Overall Compliance: No
Severity Score: 22.5			
Codes/Mitigation Info/Possible Solution		Field Measurements/Component Compliance

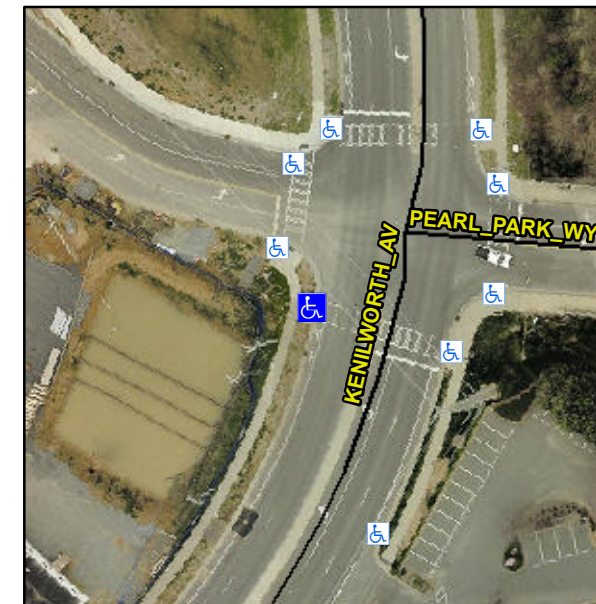
Not Found, R304.5.1, R304.2.2, R304.5.3

Compliance	Description	Data	Compliance	Description	Data
N/A	Ramp Length (in)	93.0	No	Ramp Slope (%)	8.5
No	Ramp Width (in)	47.5	No	Ramp XSlope (%)	3.0
N/A	Flare Type LT	N/A	N/A	Flare Type RT	N/A
N/A	Flare Slope LT (%)	N/A	N/A	Flare Slope RT (%)	N/A
N/A	Flare Traversable LT?	N/A	N/A	Flare Traversable RT?	N/A
N/A	Landing Length (in)	N/A	N/A	DWS Provided?	N/A
N/A	Landing Width (in)	N/A	N/A	DWS Contrast?	N/A
N/A	Landing Slope (%)	N/A	N/A	DWS Length (in)	N/A
N/A	Landing X Slope (%)	N/A	N/A	DWS Full Width?	N/A
N/A	Landing Curb? (Y/N)	N/A	N/A	DWS Offset (in)	N/A
N/A	Shared Landing?	N/A			
N/A	Gutter Ponding?	N/A	N/A	Gutter Slope (%)	N/A
N/A	Gutter Lip Ht (in)	N/A	N/A	Gutter X Slope (%)	N/A
N/A	Painted X Walk1?	Yes	N/A	Painted X Walk2?	N/A
	X Walk 1 Direction	To SE		X Walk 2 Direction	N/A
N/A	X Walk 1 Width (in)	110.0	N/A	X Walk 2 Width (in)	N/A
	X Walk 1 Slope (%)	1.5		X Walk 2 Slope (%)	N/A
	X Walk 1 X Slope (%)	0.3		X Walk 2 X Slope (%)	N/A

N/A	Ramp inside XWalk1?	Yes	N/A	Ramp inside XWalk2?	N/A
	Road Slope (%)	N/A	N/A	Clear Space?	N/A
	Road X Slope (%)	N/A	N/A	Clear Space to XWalk (in)	N/A
N/A	Any Obstructions?	N/A	N/A	Storm Grate/Utility Hazard?	N/A
	Obstruction Type			Storm Grate/Utility Type	
		N/A			N/A
		Yes		Surface Condition? (G/P)	Good

Remove & Replace Entire Ramp.
