Access Compliance Report Public Rights-of-Way (Curb Ramps)

Intersection ID: 2724 Main Street: CROWNVISTA_DR Cross Street: MORNINGSONG_LN Location: E

ADA ID: 5B266736D0BA Ramp Type: PerpDiag Initial Pass/Fail: Fail Overall Compliance: No Severity Score: 8.75

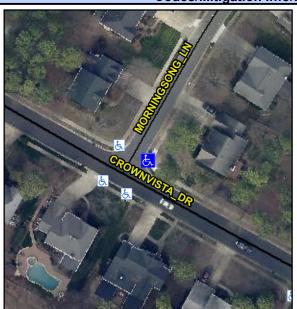
Not Found, R304.5.1

Compliance Description Data Compliance Description Data Yes Ramp Slope (%) N/A Ramp Length (in) 46.0 8.3 Yes Ramp XSlope (%) No Ramp Width (in) 38.0 0.3 N/A N/A Flare Type LT N/A Flare Type RT N/A N/A N/A N/A Flare Slope RT (%) N/A Flare Slope LT (%) N/A Flare Traversable LT? N/A N/A Flare Traversable RT? N/A N/A N/A N/A **DWS Provided?** N/A Landing Length (in) N/A Landing Width (in) N/A N/A **DWS Contrast?** N/A N/A N/A N/A Landing Slope (%) DWS Length (in) N/A N/A Landing X Slope (%) N/A N/A DWS Full Width? N/A N/A Landing Curb? (Y/N) N/A N/A DWS Offset (in) N/A N/A N/A Shared Landing? N/A Gutter Ponding? N/A N/A Gutter Slope (%) N/A N/A Gutter Lip Ht (in) N/A N/A Gutter X Slope (%) N/A N/A Painted X Walk1? No N/A Painted X Walk2? No X Walk 1 Direction To NW X Walk 2 Direction To SW N/A N/A X Walk 1 Width (in) X Walk 2 Width (in) N/A X Walk 1 Slope (%) 3.6 X Walk 2 Slope (%) 0.7 X Walk 1 X Slope (%) 0.0 X Walk 2 X Slope (%) 5.4 N/A N/A N/A Ramp inside XWalk2? N/A Ramp inside XWalk1? Road Slope (%) 3.5 N/A Clear Space? N/A

Remove & Replace Curb Ramp With Two New Directional Ramps or Equivalent.
