# Access Compliance Report

## Public Rights-of-Way

### (Curb Ramps)

Intersection ID: 18752	Main Street: SENECA_PL	Cross Street: STANFIELD_DR	Location: S
ADA ID: 5B2A0AA03246	Ramp Type: PerpDiag	Initial Pass/Fail: Fail	Overall Compliance: No
Severity Score: 33.75			
Codes/Mitigation Info/Possible Solution		Field Measurements/Component Compliance

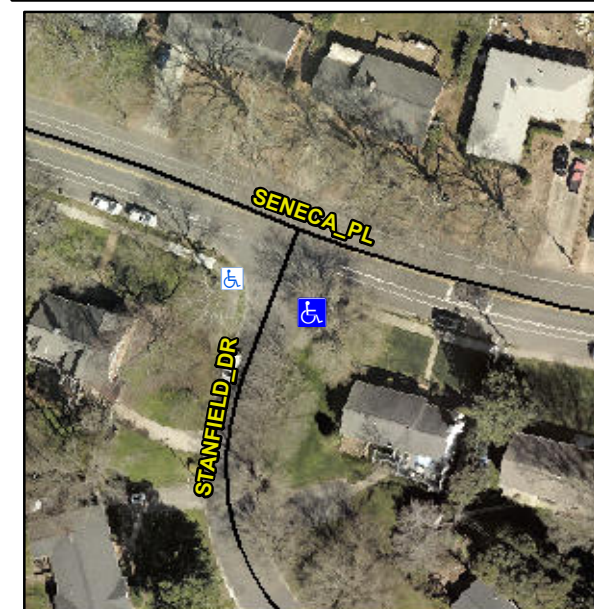
**Not Found, R304.5.1, R304.2.2**

Compliance	Description	Data	Compliance	Description	Data
N/A	Ramp Length (in)	30.0	No	Ramp Slope (%)	14.3
No	Ramp Width (in)	42.0	Yes	Ramp XSlope (%)	0.2
N/A	Flare Type LT	N/A	N/A	Flare Type RT	N/A
N/A	Flare Slope LT (%)	N/A	N/A	Flare Slope RT (%)	N/A
N/A	Flare Traversable LT?	N/A	N/A	Flare Traversable RT?	N/A
N/A	Landing Length (in)	N/A	N/A	DWS Provided?	N/A
N/A	Landing Width (in)	N/A	N/A	DWS Contrast?	N/A
N/A	Landing Slope (%)	N/A	N/A	DWS Length (in)	N/A
N/A	Landing X Slope (%)	N/A	N/A	DWS Full Width?	N/A
N/A	Landing Curb? (Y/N)	N/A	N/A	DWS Offset (in)	N/A
N/A	Shared Landing?	N/A			
N/A	Gutter Ponding?	N/A	N/A	Gutter Slope (%)	N/A
N/A	Gutter Lip Ht (in)	N/A	N/A	Gutter X Slope (%)	N/A
N/A	Painted X Walk1?	No	N/A	Painted X Walk2?	No
	X Walk 1 Direction	To NE		X Walk 2 Direction	To NW
N/A	X Walk 1 Width (in)	N/A	N/A	X Walk 2 Width (in)	N/A
	X Walk 1 Slope (%)	4.3		X Walk 2 Slope (%)	0.9
	X Walk 1 X Slope (%)	2.1		X Walk 2 X Slope (%)	4.3

N/A	Ramp inside XWalk1?	N/A	N/A	Ramp inside XWalk2?	N/A
	Road Slope (%)	2.9	N/A	Clear Space?	N/A
	Road X Slope (%)	4.5	N/A	Clear Space to XWalk (in)	N/A
N/A	Any Obstructions?	N/A	N/A	Storm Grate/Utility Hazard?	N/A
	Obstruction Type			Storm Grate/Utility Type	
		N/A			N/A
			Yes	Surface Condition? (G/P)	Good

**Remove & Replace Curb Ramp With Two New Directional Ramps or Equivalent.**

Total Cost: \$ 3200.00
