Access Compliance Report

Public Rights-of-Way

(Curb Ramps)

Intersection ID: 14278	Main Street: ROMARE_BEARDEN_DR	Cross Street: FARMER_ST	Location: NE
ADA ID: 5B3091F9CA24	Ramp Type: Perp	Initial Pass/Fail: Fail	Overall Compliance: No
Severity Score: 1.25			
Codes/Mitigation Info/Possible Solution		Field Measurements/Component Compliance

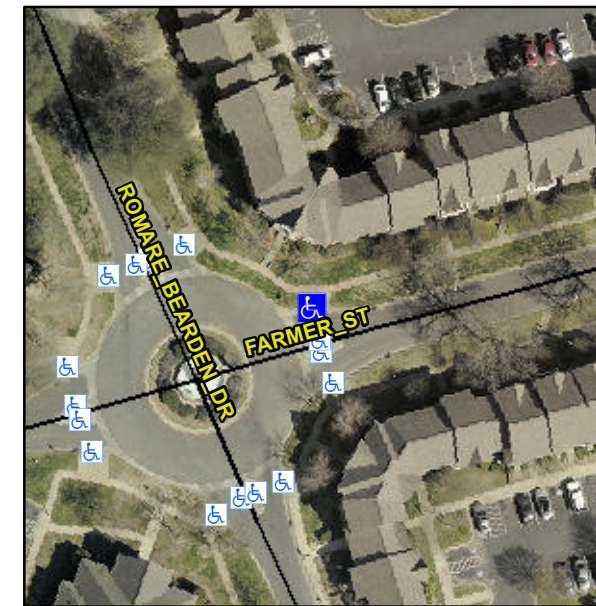
R304.5.3

Compliance	Description	Data	Compliance	Description	Data
N/A	Ramp Length (in)	97.0	Yes	Ramp Slope (%)	7.1
Yes	Ramp Width (in)	60.0	No	Ramp XSlope (%)	4.1
N/A	Flare Type LT	N/A	N/A	Flare Type RT	N/A
N/A	Flare Slope LT (%)	N/A	N/A	Flare Slope RT (%)	N/A
N/A	Flare Traversable LT?	N/A	N/A	Flare Traversable RT?	N/A
N/A	Landing Length (in)	N/A	N/A	DWS Provided?	N/A
N/A	Landing Width (in)	N/A	N/A	DWS Contrast?	N/A
N/A	Landing Slope (%)	N/A	N/A	DWS Length (in)	N/A
N/A	Landing X Slope (%)	N/A	N/A	DWS Full Width?	N/A
N/A	Landing Curb? (Y/N)	N/A	N/A	DWS Offset (in)	N/A
N/A	Shared Landing?	N/A			
N/A	Gutter Ponding?	N/A	N/A	Gutter Slope (%)	N/A
N/A	Gutter Lip Ht (in)	N/A	N/A	Gutter X Slope (%)	N/A
N/A	Painted X Walk1?	No	N/A	Painted X Walk2?	N/A
	X Walk 1 Direction	To S		X Walk 2 Direction	N/A
N/A	X Walk 1 Width (in)	N/A	N/A	X Walk 2 Width (in)	N/A
	X Walk 1 Slope (%)	0.4		X Walk 2 Slope (%)	N/A
	X Walk 1 X Slope (%)	2.9		X Walk 2 X Slope (%)	N/A

Remove & Replace Entire Ramp.
