Access Compliance Report Public Rights-of-Way (Curb Ramps)

Intersection ID: 9296 Main Street: EDDLEMAN RD Cross Street: THOMASBORO DR Location: SW **Overall Compliance: No** ADA ID: 5B39F0DDFE62 Ramp Type: Perp Initial Pass/Fail: Fail **Severity Score:** 22.5

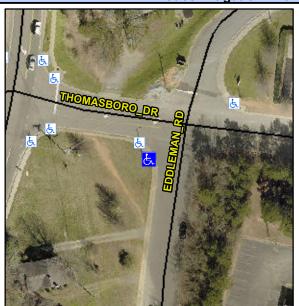
39.0 No

37.0 No

Possible Solutions:
Remove & Replace Entire Ramp.
·
Surveyor Notes:
N/A
PROW/ADA:
Not Found, R304.5.1, R304.2.2,
R304.5.3
