# Access Compliance Report

## Public Rights-of-Way

### (Curb Ramps)

Intersection ID: 25829	Main Street: GREYSON RIDGE DR	Cross Street: HIGH RIDGE RD	Location: NW
ADA ID: 5B51972B0E29	Ramp Type: PerpDiag	Initial Pass/Fail: Fail	Overall Compliance: No
Severity Score: 22.5			
Codes/Mitigation Info/Possible Solution		Field Measurements/Component Compliance

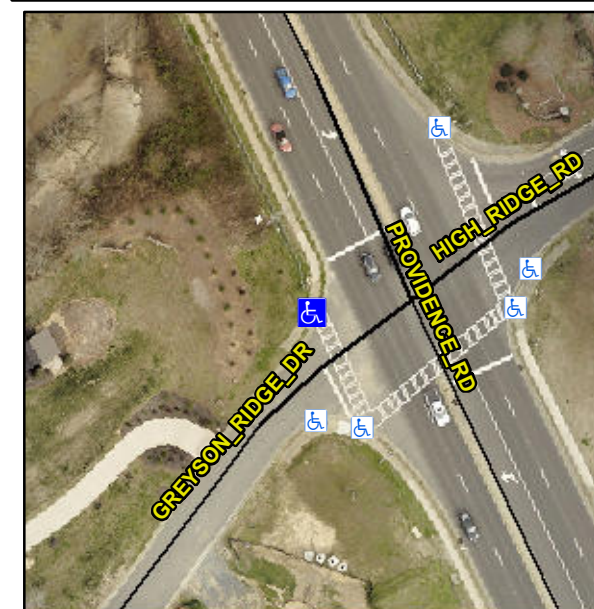
**Not Found, R304.5.1, R304.2.2**

Compliance	Description	Data	Compliance	Description	Data
N/A	Ramp Length (in)	83.0	No	Ramp Slope (%)	8.9
No	Ramp Width (in)	41.5	Yes	Ramp XSlope (%)	3.7
N/A	Flare Type LT	N/A	N/A	Flare Type RT	N/A
N/A	Flare Slope LT (%)	N/A	N/A	Flare Slope RT (%)	N/A
N/A	Flare Traversable LT?	N/A	N/A	Flare Traversable RT?	N/A
N/A	Landing Length (in)	N/A	N/A	DWS Provided?	N/A
N/A	Landing Width (in)	N/A	N/A	DWS Contrast?	N/A
N/A	Landing Slope (%)	N/A	N/A	DWS Length (in)	N/A
N/A	Landing X Slope (%)	N/A	N/A	DWS Full Width?	N/A
N/A	Landing Curb? (Y/N)	N/A	N/A	DWS Offset (in)	N/A
N/A	Shared Landing?	N/A			
N/A	Gutter Ponding?	N/A	N/A	Gutter Slope (%)	N/A
N/A	Gutter Lip Ht (in)	N/A	N/A	Gutter X Slope (%)	N/A
N/A	Painted X Walk1?	Yes	N/A	Painted X Walk2?	No
	X Walk 1 Direction	To SE		X Walk 2 Direction	To NE
N/A	X Walk 1 Width (in)	80.0	N/A	X Walk 2 Width (in)	N/A
	X Walk 1 Slope (%)	4.1		X Walk 2 Slope (%)	1.4
	X Walk 1 X Slope (%)	2.6		X Walk 2 X Slope (%)	3.8

N/A	Ramp inside XWalk1?	Yes	N/A	Ramp inside XWalk2?	N/A
	Road Slope (%)	4.0	N/A	Clear Space?	N/A
	Road X Slope (%)	1.9	N/A	Clear Space to XWalk (in)	N/A
N/A	Any Obstructions?	N/A	N/A	Storm Grate/Utility Hazard?	N/A
	Obstruction Type			Storm Grate/Utility Type	
		N/A			N/A
		Yes		Surface Condition? (G/P)	Good

**Remove & Replace Curb Ramp With Two New Directional Ramps or Equivalent.**
