Intersection ID: 13299	Main Street: FORDHAM_RD	Cross Street: OSMOND_ST	Location:	NW
ADA ID: 5B5C9D152C00	Ramp Type: PerpDiag	Initial Pass/Fail: Fail	Overall Compliance: No	Severity Score: 18.75

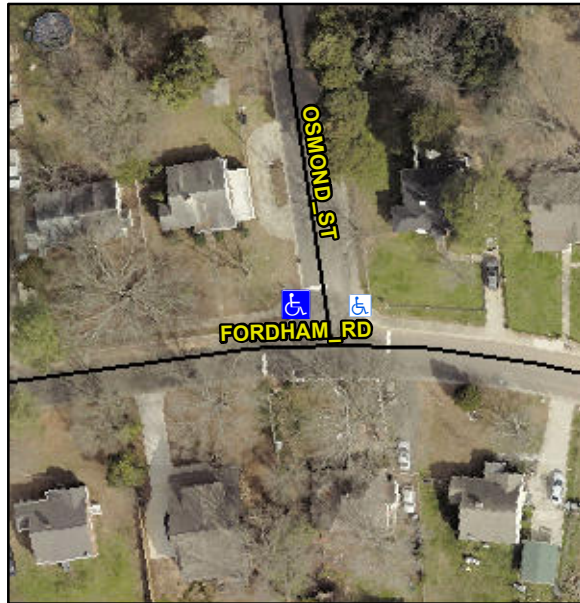
Not Found, R304.5.1, R304.5.3

Compliance	Description	Data	Compliance	Description	Data
N/A	Ramp Length (in)	47.0	Yes	Ramp Slope (%)	7.2
No	Ramp Width (in)	34.0	No	Ramp XSlope (%)	4.6
N/A	Flare Type LT	N/A	N/A	Flare Type RT	N/A
N/A	Flare Slope LT (%)	N/A	N/A	Flare Slope RT (%)	N/A
N/A	Flare Traversable LT?	N/A	N/A	Flare Traversable RT?	N/A
N/A	Landing Length (in)	N/A	N/A	DWS Provided?	N/A
N/A	Landing Width (in)	N/A	N/A	DWS Contrast?	N/A
N/A	Landing Slope (%)	N/A	N/A	DWS Length (in)	N/A
N/A	Landing X Slope (%)	N/A	N/A	DWS Full Width?	N/A
N/A	Landing Curb? (Y/N)	N/A	N/A	DWS Offset (in)	N/A
N/A	Shared Landing?	N/A			
N/A	Gutter Ponding?	N/A	N/A	Gutter Slope (%)	N/A
N/A	Gutter Lip Ht (in)	N/A	N/A	Gutter X Slope (%)	N/A
N/A	Painted X Walk1?	No	N/A	Painted X Walk2?	No
	X Walk 1 Direction	To S		X Walk 2 Direction	To E
N/A	X Walk 1 Width (in)	N/A	N/A	X Walk 2 Width (in)	N/A
	X Walk 1 Slope (%)	3.8		X Walk 2 Slope (%)	1.6
	X Walk 1 X Slope (%)	1.0		X Walk 2 X Slope (%)	3.3

N/A	Ramp inside XWalk1?	N/A	N/A	Ramp inside XWalk2?	N/A
	Road Slope (%)	2.6	N/A	Clear Space?	N/A
	Road X Slope (%)	0.5	N/A	Clear Space to XWalk (in)	N/A
N/A	Any Obstructions?	N/A	N/A	Storm Grate/Utility Hazard?	N/A
	Obstruction Type			Storm Grate/Utility Type	
		N/A			N/A
			Yes	Surface Condition? (G/P)	Good

Remove & Replace Curb Ramp With Two New Directional Ramps or Equivalent.
