# Access Compliance Report

## Public Rights-of-Way

### (Curb Ramps)

Intersection ID: 10037884	Main Street: SHARON_VIEW_RD	Cross Street: N/A	Location: SE
ADA ID: 5B5EC2871964	Ramp Type: PerpDiag	Initial Pass/Fail: Fail	Overall Compliance: No
Severity Score: 22.5			
Codes/Mitigation Info/Possible Solution		Field Measurements/Component Compliance

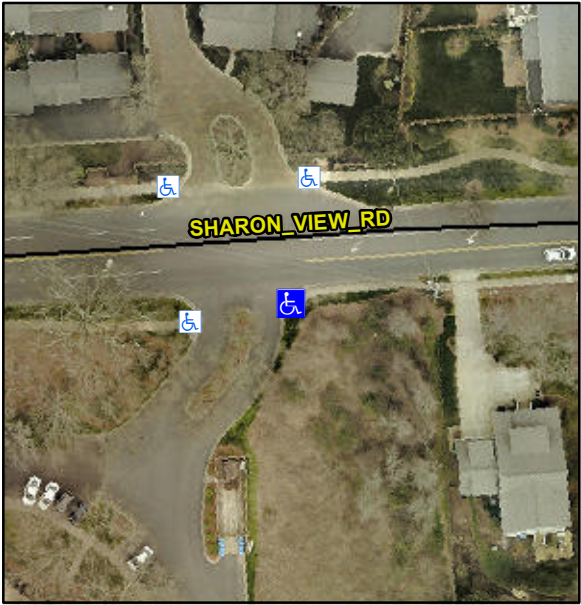
Possible Solutions:	Compliance	Description	Data	Compliance	Description	Data
	Remove & Replace Curb Ramp With Two New Directional Ramps or Equivalent.	N/A	Ramp Length (in)	65.0	No	Ramp Slope (%)	8.8
		No	Ramp Width (in)	47.0	No	Ramp XSlope (%)	2.9
		N/A	Flare Type LT	N/A	N/A	Flare Type RT	N/A
		N/A	Flare Slope LT (%)	N/A	N/A	Flare Slope RT (%)	N/A
		N/A	Flare Traversable LT?	N/A	N/A	Flare Traversable RT?	N/A
		N/A	Landing Length (in)	N/A	N/A	DWS Provided?	N/A
		N/A	Landing Width (in)	N/A	N/A	DWS Contrast?	N/A
		N/A	Landing Slope (%)	N/A	N/A	DWS Length (in)	N/A
		N/A	Landing X Slope (%)	N/A	N/A	DWS Full Width?	N/A
<p>Surveyor Notes:</p> <p>N/A</p> <p>PROW/ADA:</p> <p>R304.5.1, R304.2.2, R304.5.3</p>		N/A	Landing Curb? (Y/N)	N/A	N/A	DWS Offset (in)	N/A
		N/A	Shared Landing?	N/A			
		N/A	Gutter Ponding?	N/A	N/A	Gutter Slope (%)	N/A
		N/A	Gutter Lip Ht (in)	N/A	N/A	Gutter X Slope (%)	N/A
		N/A	Painted X Walk1?	No	N/A	Painted X Walk2?	No

X Walk 1 Direction	To N		X Walk 2 Direction	To W
		N/A	X Walk 1 Width (in)	N/A	N/A	X Walk 2 Width (in)	N/A
			X Walk 1 Slope (%)	1.4		X Walk 2 Slope (%)	1.5
			X Walk 1 X Slope (%)	2.0		X Walk 2 X Slope (%)	0.3
		N/A	Ramp inside XWalk1?	N/A	N/A	Ramp inside XWalk2?	N/A
<p>Street 1 Name SHARON VIEW RD</p> <p>Stop Condition-Street 2 None</p> <p>Street 2 Name ENTRANCE</p> <p>Stop Condition-Street 1 None</p>			Road Slope (%)	1.5	N/A	Clear Space?	N/A
			Road X Slope (%)	0.4	N/A	Clear Space to XWalk (in)	N/A
		N/A	Any Obstructions?	N/A	N/A	Storm Grate/Utility Hazard?	N/A
			Obstruction Type			Storm Grate/Utility Type	
					N/A		N/A
					Yes	Surface Condition? (G/P)	Good
	Total Cost:	\$	3200.00
