## **Access Compliance Report Public Rights-of-Way** (Curb Ramps)

Intersection ID: 7973 Main Street: HOVIS\_RD Cross Street: TAR\_HEEL\_RD Location: SW **Overall Compliance: No** ADA ID: 5B6319C6A176 Ramp Type: Perp Initial Pass/Fail: Fail Severity Score: 21.25

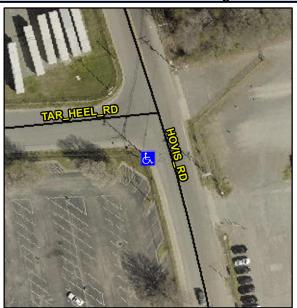
Field Measurements/Component Compliance										
Compliance Description		Data	Comp	liance	Description	Data				
N/A	Ramp Length (in)	49.0	No	Ramp	Slope (%)	10.9				
No	Ramp Width (in)	38.0	Yes	Ramp	XSlope (%)	0.9				
N/A	Flare Type LT	N/A	N/A	Flare	Type RT	N/A				
N/A	Flare Slope LT (%)	N/A	N/A	Flare	Slope RT (%)	N/A				
N/A	Flare Traversable LT?	N/A	N/A	Flare	Traversable RT?	N/A				
N/A	Landing Length (in)	N/A	N/A	DWS	Provided?	N/A				
N/A	Landing Width (in)	N/A	N/A	DWS	Contrast?	N/A				
N/A	Landing Slope (%)	N/A	N/A	DWS	Length (in)	N/A				
N/A	Landing X Slope (%)	N/A	N/A	DWS	Full Width?	N/A				
N/A	Landing Curb? (Y/N)	N/A	N/A	DWS	Offset (in)	N/A				
N/A	Shared Landing?	N/A								
N/A	Gutter Ponding?	N/A	N/A	Gutte	r Slope (%)	N/A				
N/A	Gutter Lip Ht (in)	N/A	N/A	Gutte	r X Slope (%)	N/A				
N/A	Painted X Walk1?	No	N/A	Painte	ed X Walk2?	N/A				
	X Walk 1 Direction	To N		X Wa	lk 2 Direction	N/A				
N/A	X Walk 1 Width (in)	N/A	N/A	X Wa	lk 2 Width (in)	N/A

X Walk 1 Slope (%)	0.2		X Wa	lk 2 Slope (%)	N/A				
	X Walk 1 X Slope (%)	6.6		X Wa	lk 2 X Slope (%)	N/A				
N/A	Ramp inside XWalk1?	N/A	N/A	Ramp	inside XWalk2?	N/A				
	Road Slope (%)	6.6	N/A	Clear	Space?	N/A				
	Road X Slope (%)	0.2	N/A	Clear	Space to XWalk (in)	N/A				
N/A	Any Obstructions?	N/A	N/A	Storm	Grate/Utility Hazard?	N/A				
	Obstruction Type			Storm	Grate/Utility Type					
		N/A				N/A				
			Yes	Surfa	ce Condition? (G/P)	Good

Possible Solutions:						
The same of	Remove & Replace Entire Ramp.						
í							
ı							
ı	Surveyor Notes:						
	Surveyor Notes:						
ĺ	N/A						
	PROW/ADA:						
ı	Not Found, R304.5.1, R304.2.2						
	Not i ouiiu, 1304.5.1, 1304.2.2						
_
