# Access Compliance Report

## Public Rights-of-Way

### (Curb Ramps)

Intersection ID: 21496	Main Street: SOUTH_BV	Cross Street: STARMOUNT_COVE_LN	Location: NE
ADA ID: 5B69DD645F89	Ramp Type: ParaDiag	Initial Pass/Fail: Fail	Overall Compliance: No
			Severity Score: 13.75

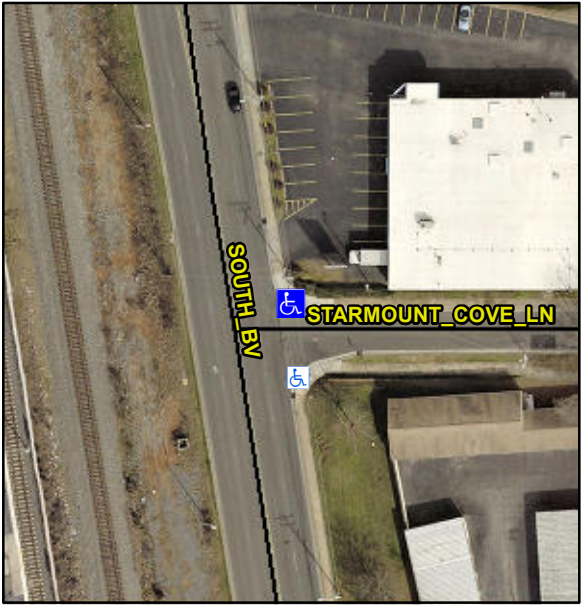
Compliance	Description	Data	Compliance	Description	Data
N/A	Ramp Length LT (in)	70.0	N/A	Ramp Length RT (in)	37.0
Yes	Ramp Width LT (in)	60.0	Yes	Ramp Width RT (in)	58.0
No	Ramp Slope LT (%)	8.8	Yes	Ramp Slope RT (%)	7.6
No	Ramp XSlope LT (%)	2.1	Yes	Ramp XSlope RT (%)	1.1
N/A	Landing Length (in)	N/A	N/A	DWS Provided?	N/A
N/A	Landing Width (in)	N/A	N/A	DWS Contrast?	N/A
N/A	Landing Slope (%)	N/A	N/A	DWS Length (in)	N/A
N/A	Landing X Slope (%)	N/A	N/A	DWS Full Width?	N/A
N/A	Landing Curb? (Y/N)	N/A	N/A	DWS Offset (in)	N/A
N/A	Shared Landing?	N/A			
N/A	Gutter Ponding?	N/A	N/A	Gutter Slope (%)	N/A
N/A	Gutter Lip Ht (in)	N/A	N/A	Gutter X Slope (%)	N/A
N/A	Painted X Walk1?	No	N/A	Painted X Walk2?	No
	X Walk 1 Direction	To W		X Walk 2 Direction	To SE
N/A	X Walk 1 Width (in)	N/A	N/A	X Walk 2 Width (in)	N/A
	X Walk 1 Slope (%)	3.4		X Walk 2 Slope (%)	0.3
	X Walk 1 X Slope (%)	2.1		X Walk 2 X Slope (%)	4.2
N/A	Ramp inside XWalk1?	N/A	N/A	Ramp inside XWalk2?	N/A

Road Slope (%)	4.0	N/A	Clear Space?	N/A
	Road X Slope (%)	2.3	N/A	Clear Space to XWalk (in)	N/A
N/A	Any Obstructions?	N/A	N/A	Storm Grate/Utility Hazard?	N/A
	Obstruction Type			Storm Grate/Utility Type	
		N/A			N/A
			Yes	Surface Condition? (G/P)	Good
			N/A	Curb Slope (%)	0.2

Possible Solutions:				
	<b>Remove &amp; Replace Curb Ramp With Two New Directional Ramps or Equivalent.</b>				
	Surveyor Notes:				
	<b>N/A</b>				
	PROW/ADA:				
	<b>R304.3.2, R304.5.3</b>				
Street 1 Name	<b>SOUTH BV</b>				
Stop Condition-Street 1	<b>None</b>				
Street 2 Name	<b>STARMOUNT COVE LN</b>				
Stop Condition-Street 2	<b>StopSign</b>				
Total Cost:		\$	<b>3200.00</b>
