Access Compliance Report Public Rights-of-Way (Curb Ramps)

Intersection ID: 18108	Intersection ID: 18108 Main Street: E_WOODLAWN_RD			Street:	STACY_BV	Location:	NE		
ADA ID: 5B7A6CE56A1	6CE56A1D Ramp Type: PerpDiag			Initial Pass/Fail: Fail Overall Compliance: No				o Severity Score:	8.75
Codes/Mitigation Info/Possible Solution				Field Measurements/Component Compliance					
		Possible Solutions:		Compliance Description		Data	Data Compliance Description		Data
		Remove & Replace Curb Ram	o With	N/A	Ramp Length (in)	125.0	Yes	Ramp Slope (%)	7.0
and the second sec		Two New Directional Ramps or		No	Ramp Width (in)	43.0	Yes	Ramp XSlope (%)	1.1
A PARTY A	The same and	Equivalent.		N/A	Flare Type LT	N/A	N/A	Flare Type RT	N/A
	10 10 10 10 10 10 10 10 10 10 10 10 10 1			N/A	Flare Slope LT (%)	N/A	N/A	Flare Slope RT (%)	N/A
	ALL ALLAN			N/A	Flare Traversable LT?	N/A	N/A	Flare Traversable RT?	N/A
6	ALL ALL ALL			N/A	Landing Length (in)	N/A	N/A	DWS Provided?	N/A
	Waldwerd H	Surveyor Notes:		N/A	Landing Width (in)	N/A	N/A	DWS Contrast?	N/A

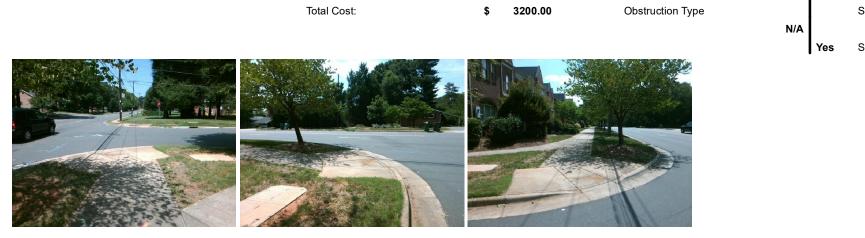
N/A ROW/ADA: Not Found, R304.5.1				N/A	Landing Slope (%)	N/A	N/A	DWS Length (in)	N/A
				N/A	Landing X Slope (%)	N/A	N/A	DWS Full Width?	N/A
				N/A	Landing Curb? (Y/N)	N/A	N/A	DWS Offset (in)	N/A
				N/A	Shared Landing?	N/A			
				N/A	Gutter Ponding?	N/A	N/A	Gutter Slope (%)	N/A
				N/A	Gutter Lip Ht (in)	1.0	N/A	Gutter X Slope (%)	N/A
				N/A	Painted X Walk1?	No	N/A	Painted X Walk2?	No
					X Walk 1 Direction	To W		X Walk 2 Direction	To S
	A Comment			N/A	X Walk 1 Width (in)	N/A	N/A	X Walk 2 Width (in)	N/A
Street 1 Name	STACY BV				X Walk 1 Slope (%)	0.2		X Walk 2 Slope (%)	0.2
Stop Condition-Street 2	StopSign				X Walk 1 X Slope (%)	1.1		X Walk 2 X Slope (%)	1.0
Street 2 Name	E WOODLAWN RD			N/A	Ramp inside XWalk1?	N/A	N/A	Ramp inside XWalk2?	N/A
Stop Condition-Street 1	None				Road Slope (%)	0.5	N/A	Clear Space?	N/A
					Road X Slope (%)	0.0	N/A	Clear Space to XWalk (in)	N/A
				N/A	Any Obstructions?	N/A	N/A	Storm Grate/Utility Hazard?	N/A

Total Cost: \$	3200.00		Obstruction Type			Storm Grate/Utility Type	
						N/A			N/A
