Access Compliance Report

Public Rights-of-Way

(Curb Ramps)

Intersection ID: 31215	Main Street: OLDEHURST_PL	Cross Street: WRAYHILL_DR	Location: NW
ADA ID: 5B82CCD25B33	Ramp Type: PerpDiag	Initial Pass/Fail: Fail	Overall Compliance: No
Severity Score: 31.25			
Codes/Mitigation Info/Possible Solution		Field Measurements/Component Compliance

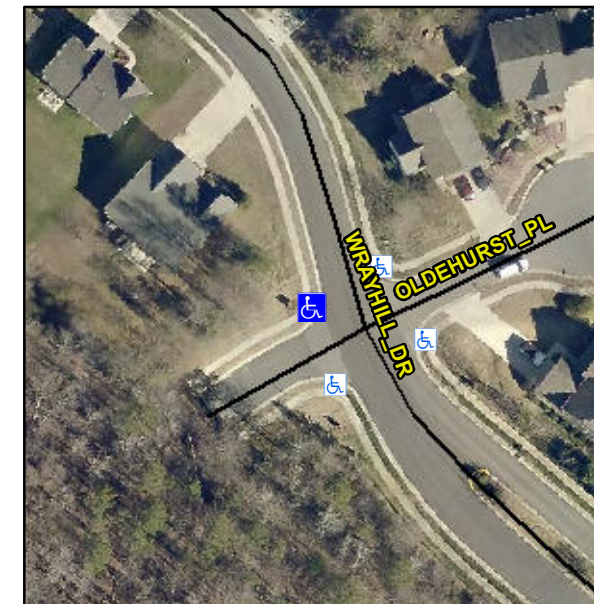
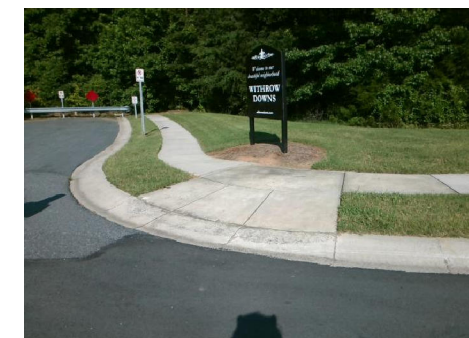
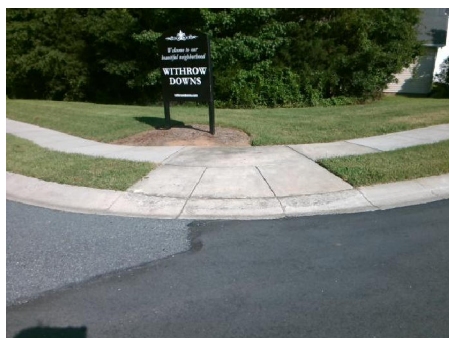
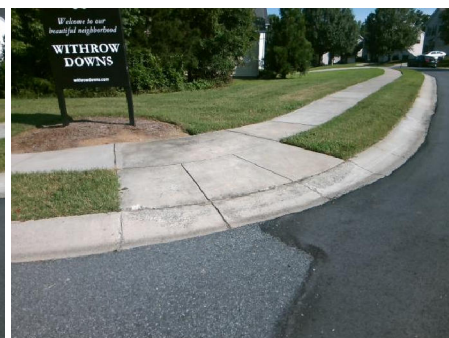
Not Found, R304.5.1, R304.2.2, R304.5.3

Compliance	Description	Data	Compliance	Description	Data
N/A	Ramp Length (in)	48.0	No	Ramp Slope (%)	8.9
No	Ramp Width (in)	33.0	No	Ramp XSlope (%)	4.7
N/A	Flare Type LT	N/A	N/A	Flare Type RT	N/A
N/A	Flare Slope LT (%)	N/A	N/A	Flare Slope RT (%)	N/A
N/A	Flare Traversable LT?	N/A	N/A	Flare Traversable RT?	N/A
N/A	Landing Length (in)	N/A	N/A	DWS Provided?	N/A
N/A	Landing Width (in)	N/A	N/A	DWS Contrast?	N/A
N/A	Landing Slope (%)	N/A	N/A	DWS Length (in)	N/A
N/A	Landing X Slope (%)	N/A	N/A	DWS Full Width?	N/A
N/A	Landing Curb? (Y/N)	N/A	N/A	DWS Offset (in)	N/A
N/A	Shared Landing?	N/A			
N/A	Gutter Ponding?	N/A	N/A	Gutter Slope (%)	N/A
N/A	Gutter Lip Ht (in)	N/A	N/A	Gutter X Slope (%)	N/A
N/A	Painted X Walk1?	No	N/A	Painted X Walk2?	No
	X Walk 1 Direction	To S		X Walk 2 Direction	To E
N/A	X Walk 1 Width (in)	N/A	N/A	X Walk 2 Width (in)	N/A
	X Walk 1 Slope (%)	1.2		X Walk 2 Slope (%)	0.3
	X Walk 1 X Slope (%)	0.6		X Walk 2 X Slope (%)	1.5

N/A	Ramp inside XWalk1?	N/A	N/A	Ramp inside XWalk2?	N/A
	Road Slope (%)	1.6	N/A	Clear Space?	N/A
	Road X Slope (%)	0.2	N/A	Clear Space to XWalk (in)	N/A
N/A	Any Obstructions?	N/A	N/A	Storm Grate/Utility Hazard?	N/A
	Obstruction Type			Storm Grate/Utility Type	
		N/A			N/A
			Yes	Surface Condition? (G/P)	Good

Remove & Replace Curb Ramp With Two New Directional Ramps or Equivalent.
