# Access Compliance Report

## Public Rights-of-Way

### (Curb Ramps)

Intersection ID: 31209	Main Street: CAPRINGTON_AV	Cross Street: CLACKWYCK_LN	Location: W
ADA ID: 5B8F00615EFC	Ramp Type: Perp	Initial Pass/Fail: Fail	Overall Compliance: No
Severity Score: 12.5			
Codes/Mitigation Info/Possible Solution		Field Measurements/Component Compliance

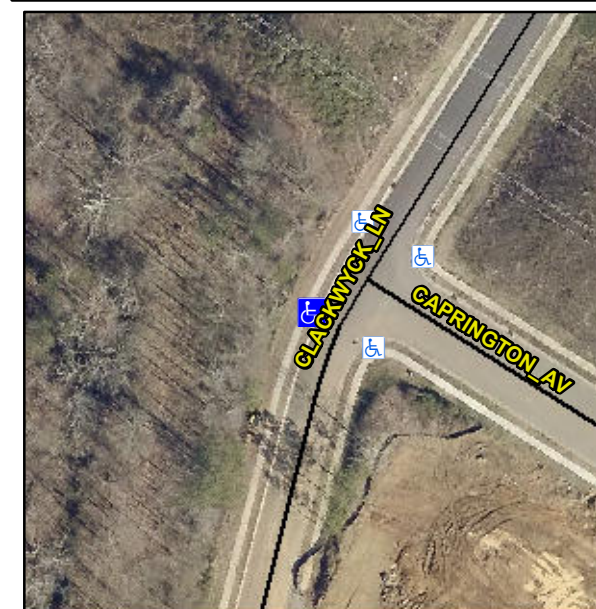
**Not Found, R304.5.3**

Compliance	Description	Data	Compliance	Description	Data
N/A	Ramp Length (in)	59.0	Yes	Ramp Slope (%)	6.5
Yes	Ramp Width (in)	53.0	No	Ramp XSlope (%)	5.4
N/A	Flare Type LT	N/A	N/A	Flare Type RT	N/A
N/A	Flare Slope LT (%)	N/A	N/A	Flare Slope RT (%)	N/A
N/A	Flare Traversable LT?	N/A	N/A	Flare Traversable RT?	N/A
N/A	Landing Length (in)	N/A	N/A	DWS Provided?	N/A
N/A	Landing Width (in)	N/A	N/A	DWS Contrast?	N/A
N/A	Landing Slope (%)	N/A	N/A	DWS Length (in)	N/A
N/A	Landing X Slope (%)	N/A	N/A	DWS Full Width?	N/A
N/A	Landing Curb? (Y/N)	N/A	N/A	DWS Offset (in)	N/A
N/A	Shared Landing?	N/A			
N/A	Gutter Ponding?	N/A	N/A	Gutter Slope (%)	N/A
N/A	Gutter Lip Ht (in)	N/A	N/A	Gutter X Slope (%)	N/A
N/A	Painted X Walk1?	No	N/A	Painted X Walk2?	N/A
	X Walk 1 Direction	To SE		X Walk 2 Direction	N/A
N/A	X Walk 1 Width (in)	N/A	N/A	X Walk 2 Width (in)	N/A
	X Walk 1 Slope (%)	5.7		X Walk 2 Slope (%)	N/A
	X Walk 1 X Slope (%)	2.3		X Walk 2 X Slope (%)	N/A

N/A	Ramp inside XWalk1?	N/A	N/A	Ramp inside XWalk2?	N/A
	Road Slope (%)	N/A	N/A	Clear Space?	N/A
	Road X Slope (%)	N/A	N/A	Clear Space to XWalk (in)	N/A
N/A	Any Obstructions?	N/A	N/A	Storm Grate/Utility Hazard?	N/A
	Obstruction Type			Storm Grate/Utility Type	
		N/A			N/A
			Yes	Surface Condition? (G/P)	Good

Possible Solutions:

**Remove & Replace Entire Ramp.**

Total Cost: \$ 1850.00
