Intersection ID: 18726	Main Street: TYVOLA_RD	Cross Street: OLD_PINEVILLE_RD	Location:	NE
ADA ID: 5B941767B8BC	Ramp Type: Perp	Initial Pass/Fail: Fail	Overall Compliance: No	Severity Score: 21.25

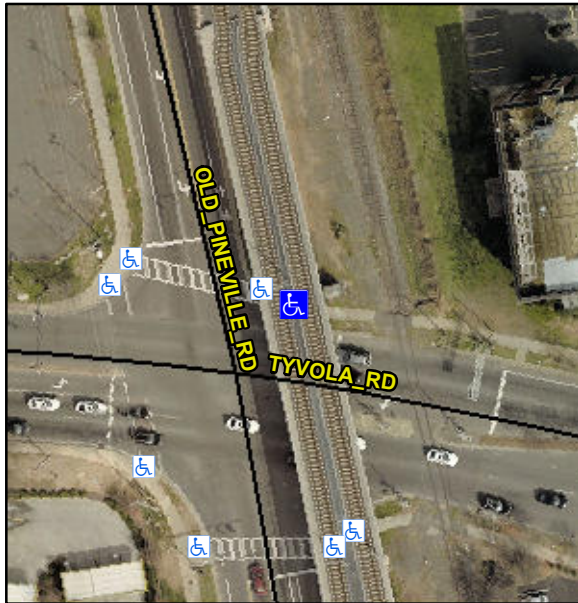
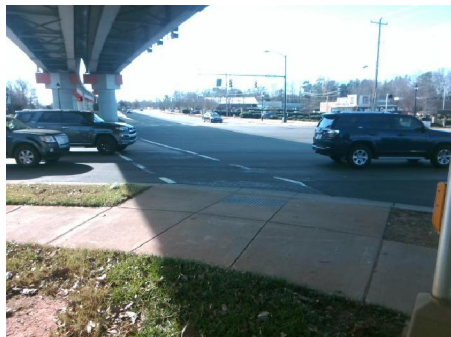
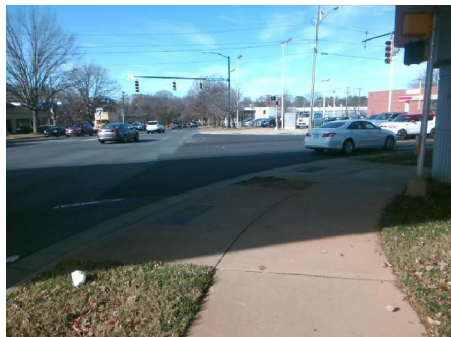
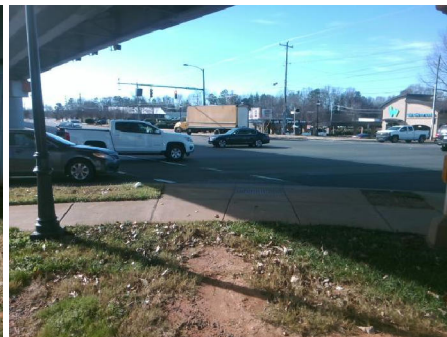
**Not Found, R304.5.1, R304.2.2**

Possible Solutions:			Compliance	Description	Data	Compliance	Description	Data
<b>Remove &amp; Replace Entire Ramp.</b>			N/A	Ramp Length (in)	71.0	No	Ramp Slope (%)	8.9
			No	Ramp Width (in)	47.5	Yes	Ramp XSlope (%)	0.9
			N/A	Flare Type LT	N/A	N/A	Flare Type RT	N/A
			N/A	Flare Slope LT (%)	N/A	N/A	Flare Slope RT (%)	N/A
			N/A	Flare Traversable LT?	N/A	N/A	Flare Traversable RT?	N/A
			N/A	Landing Length (in)	N/A	N/A	DWS Provided?	N/A
			N/A	Landing Width (in)	N/A	N/A	DWS Contrast?	N/A
			N/A	Landing Slope (%)	N/A	N/A	DWS Length (in)	N/A
			N/A	Landing X Slope (%)	N/A	N/A	DWS Full Width?	N/A
			N/A	Landing Curb? (Y/N)	N/A	N/A	DWS Offset (in)	N/A
			N/A	Shared Landing?	N/A			
			N/A	Gutter Ponding?	N/A	N/A	Gutter Slope (%)	N/A
			N/A	Gutter Lip Ht (in)	N/A	N/A	Gutter X Slope (%)	N/A
			N/A	Painted X Walk1?	Yes	N/A	Painted X Walk2?	N/A
				X Walk 1 Direction	To S		X Walk 2 Direction	N/A
N/A	X Walk 1 Width (in)	106.0	N/A	X Walk 2 Width (in)	N/A

X Walk 1 Slope (%)	2.2		X Walk 2 Slope (%)	N/A			
	X Walk 1 X Slope (%)	1.9		X Walk 2 X Slope (%)	N/A			
N/A	Ramp inside XWalk1?	Yes	N/A	Ramp inside XWalk2?	N/A			
	Road Slope (%)	N/A	N/A	Clear Space?	N/A			
	Road X Slope (%)	N/A	N/A	Clear Space to XWalk (in)	N/A			
N/A	Any Obstructions?	N/A	N/A	Storm Grate/Utility Hazard?	N/A			
Total Cost:	\$	1850.00		Obstruction Type		Storm Grate/Utility Type		
					N/A			N/A
						Yes	Surface Condition? (G/P)	Good

### Remove & Replace Entire Ramp.
