Intersection ID: 44915	Main Street: OAKBURN_DR	Cross Street: BERRYBROOK_LN	Location:	N
ADA ID: 5BA3DFBE1521	Ramp Type: Perp	Initial Pass/Fail: Fail	Overall Compliance: No	Severity Score: 10

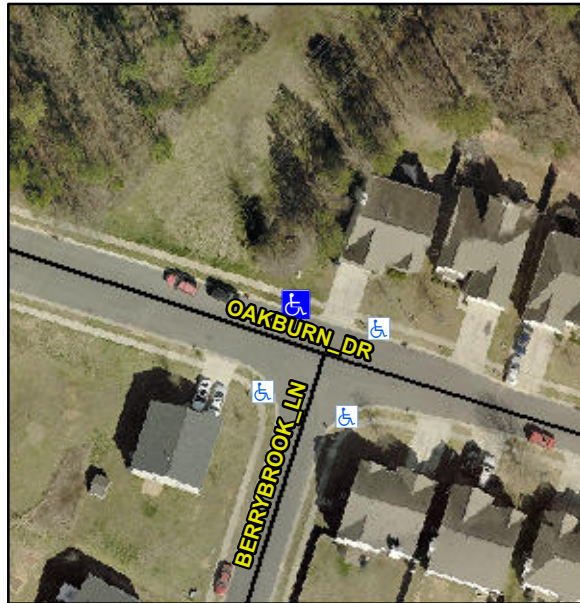
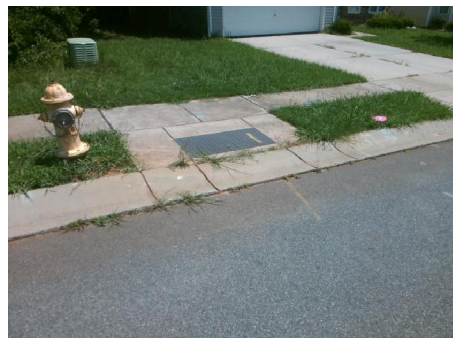
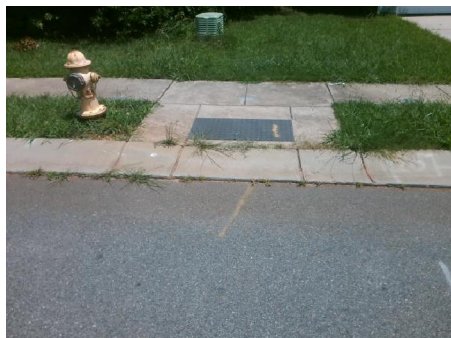
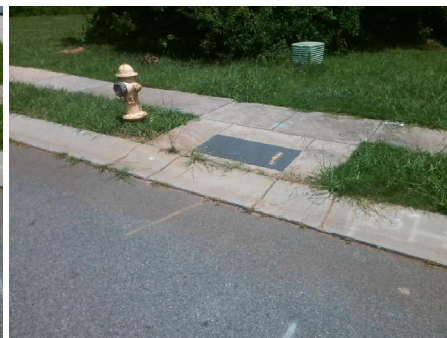
Not Found, R304.5.1, R304.5.3

Compliance	Description	Data	Compliance	Description	Data
N/A	Ramp Length (in)	48.0	Yes	Ramp Slope (%)	6.6
No	Ramp Width (in)	47.5	No	Ramp XSlope (%)	3.1
N/A	Flare Type LT	N/A	N/A	Flare Type RT	N/A
N/A	Flare Slope LT (%)	N/A	N/A	Flare Slope RT (%)	N/A
N/A	Flare Traversable LT?	N/A	N/A	Flare Traversable RT?	N/A
N/A	Landing Length (in)	N/A	N/A	DWS Provided?	N/A
N/A	Landing Width (in)	N/A	N/A	DWS Contrast?	N/A
N/A	Landing Slope (%)	N/A	N/A	DWS Length (in)	N/A
N/A	Landing X Slope (%)	N/A	N/A	DWS Full Width?	N/A
N/A	Landing Curb? (Y/N)	N/A	N/A	DWS Offset (in)	N/A
N/A	Shared Landing?	N/A			
N/A	Gutter Ponding?	N/A	N/A	Gutter Slope (%)	N/A
N/A	Gutter Lip Ht (in)	N/A	N/A	Gutter X Slope (%)	N/A
N/A	Painted X Walk1?	No	N/A	Painted X Walk2?	N/A
	X Walk 1 Direction	To SW		X Walk 2 Direction	N/A
N/A	X Walk 1 Width (in)	N/A	N/A	X Walk 2 Width (in)	N/A
	X Walk 1 Slope (%)	2.9		X Walk 2 Slope (%)	N/A
	X Walk 1 X Slope (%)	2.6		X Walk 2 X Slope (%)	N/A

N/A	Ramp inside XWalk1?	N/A	N/A	Ramp inside XWalk2?	N/A
	Road Slope (%)	N/A	N/A	Clear Space?	N/A
	Road X Slope (%)	N/A	N/A	Clear Space to XWalk (in)	N/A
N/A	Any Obstructions?	N/A	N/A	Storm Grate/Utility Hazard?	N/A
	Obstruction Type			Storm Grate/Utility Type	
		N/A			N/A
			Yes	Surface Condition? (G/P)	Good

Remove & Replace Entire Ramp.
