# Access Compliance Report

## Public Rights-of-Way

### (Curb Ramps)

Intersection ID: 12977	Main Street: W_PALMER_ST	Cross Street: S_CHURCH_ST	Location: SW
ADA ID: 5BA6533A7E2F	Ramp Type: Perp	Initial Pass/Fail: Fail	Overall Compliance: No
Severity Score: 25			
Codes/Mitigation Info/Possible Solution		Field Measurements/Component Compliance

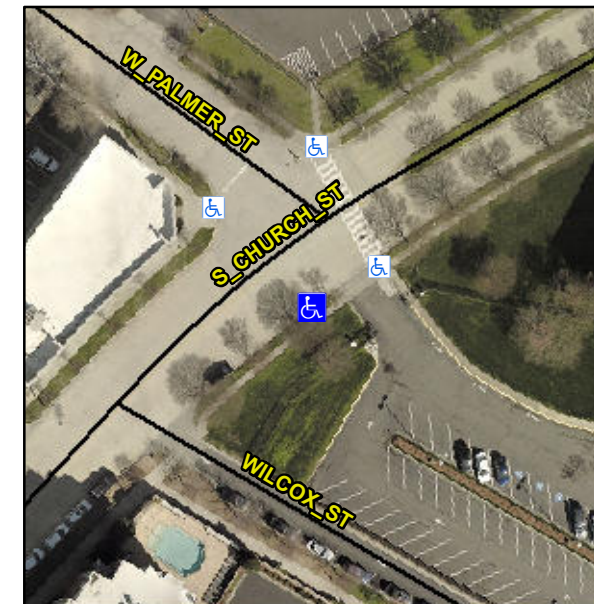
**Not Found, R304.2.2, R304.5.3**

Compliance	Description	Data	Compliance	Description	Data
N/A	Ramp Length (in)	49.0	No	Ramp Slope (%)	9.8
Yes	Ramp Width (in)	48.0	No	Ramp XSlope (%)	6.4
N/A	Flare Type LT	N/A	N/A	Flare Type RT	N/A
N/A	Flare Slope LT (%)	N/A	N/A	Flare Slope RT (%)	N/A
N/A	Flare Traversable LT?	N/A	N/A	Flare Traversable RT?	N/A
N/A	Landing Length (in)	N/A	N/A	DWS Provided?	N/A
N/A	Landing Width (in)	N/A	N/A	DWS Contrast?	N/A
N/A	Landing Slope (%)	N/A	N/A	DWS Length (in)	N/A
N/A	Landing X Slope (%)	N/A	N/A	DWS Full Width?	N/A
N/A	Landing Curb? (Y/N)	N/A	N/A	DWS Offset (in)	N/A
N/A	Shared Landing?	N/A			
N/A	Gutter Ponding?	N/A	N/A	Gutter Slope (%)	N/A
N/A	Gutter Lip Ht (in)	N/A	N/A	Gutter X Slope (%)	N/A
N/A	Painted X Walk1?	No	N/A	Painted X Walk2?	N/A
	X Walk 1 Direction	To NW		X Walk 2 Direction	N/A
N/A	X Walk 1 Width (in)	N/A	N/A	X Walk 2 Width (in)	N/A
	X Walk 1 Slope (%)	2.3		X Walk 2 Slope (%)	N/A
	X Walk 1 X Slope (%)	1.7		X Walk 2 X Slope (%)	N/A

N/A	Ramp inside XWalk1?	N/A	N/A	Ramp inside XWalk2?	N/A
	Road Slope (%)	N/A	N/A	Clear Space?	N/A
	Road X Slope (%)	N/A	N/A	Clear Space to XWalk (in)	N/A
N/A	Any Obstructions?	N/A	N/A	Storm Grate/Utility Hazard?	N/A
	Obstruction Type			Storm Grate/Utility Type	
		N/A			N/A
			Yes	Surface Condition? (G/P)	Good

**Remove & Replace Entire Ramp.**
