Access Compliance Report

Public Rights-of-Way

(Curb Ramps)

Intersection ID: 5987	Main Street: OAK_DR	Cross Street: OAKBLUFF_CR	Location:	E
ADA ID: 5BA896C5C949	Ramp Type: Perp	Initial Pass/Fail: Fail	Overall Compliance: No	Severity Score: 1.25

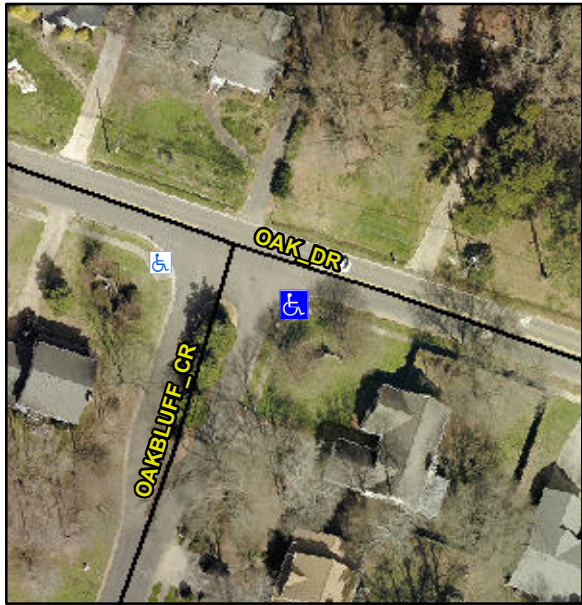
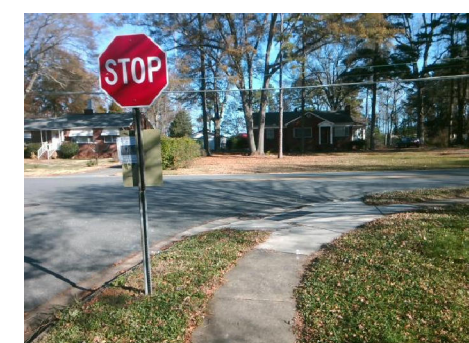
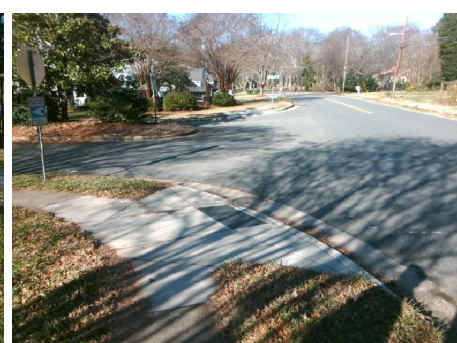
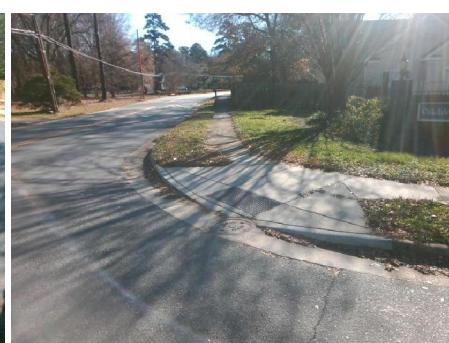
Possible Solutions:		Compliance	Description	Data	Compliance	Description	Data
	Remove & Replace Entire Ramp.		N/A	Ramp Length (in)	101.0	Yes	Ramp Slope (%)	5.3
			Yes	Ramp Width (in)	48.5	No	Ramp XSlope (%)	4.6
			N/A	Flare Type LT	N/A	N/A	Flare Type RT	N/A
			N/A	Flare Slope LT (%)	N/A	N/A	Flare Slope RT (%)	N/A
			N/A	Flare Traversable LT?	N/A	N/A	Flare Traversable RT?	N/A
			N/A	Landing Length (in)	N/A	N/A	DWS Provided?	N/A
			N/A	Landing Width (in)	N/A	N/A	DWS Contrast?	N/A
			N/A	Landing Slope (%)	N/A	N/A	DWS Length (in)	N/A
			N/A	Landing X Slope (%)	N/A	N/A	DWS Full Width?	N/A
Surveyor Notes:		N/A	N/A	Landing Curb? (Y/N)	N/A	N/A	DWS Offset (in)	N/A
PROW/ADA:		Not Found, R304.5.3	N/A	Shared Landing?	N/A			
			N/A	Gutter Ponding?	N/A	N/A	Gutter Slope (%)	N/A
			N/A	Gutter Lip Ht (in)	N/A	N/A	Gutter X Slope (%)	N/A
