# Access Compliance Report

## Public Rights-of-Way

### (Curb Ramps)

Intersection ID: 10038266	Main Street: SMITHFIELD_CHURCH_RD	Cross Street: N/A	Location: SE
ADA ID: 5BAB7CF6B0BF	Ramp Type: PerpDiag	Initial Pass/Fail: Fail	Overall Compliance: No
Codes/Mitigation Info/Possible Solution		Field Measurements/Component Compliance

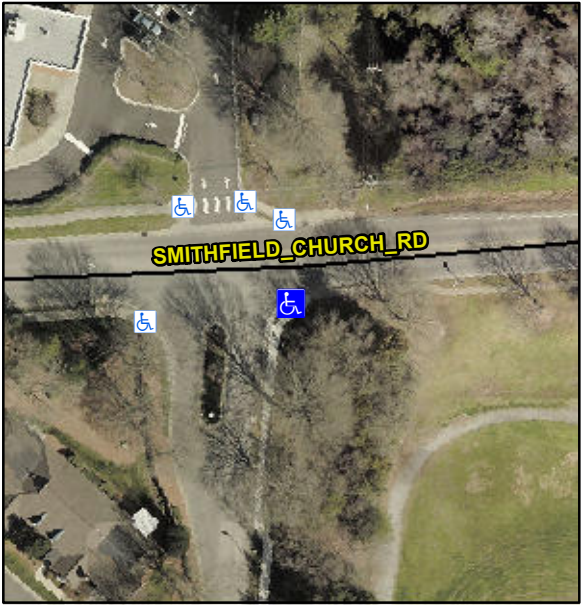
Possible Solutions:	Compliance	Description	Data	Compliance	Description	Data
	Remove & Replace Curb Ramp With Two New Directional Ramps or Equivalent.	N/A	Ramp Length (in)	48.0	Yes	Ramp Slope (%)	5.8
<p>Surveyor Notes:</p> <p>N/A</p> <p>PROW/ADA:</p> <p>Not Found, R304.5.1, R304.5.3</p>		No	Ramp Width (in)	43.5	No	Ramp XSlope (%)	2.4
		N/A	Flare Type LT	N/A	N/A	Flare Type RT	N/A
		N/A	Flare Slope LT (%)	N/A	N/A	Flare Slope RT (%)	N/A
		N/A	Flare Traversable LT?	N/A	N/A	Flare Traversable RT?	N/A
		N/A	Landing Length (in)	N/A	N/A	DWS Provided?	N/A
		N/A	Landing Width (in)	N/A	N/A	DWS Contrast?	N/A
		N/A	Landing Slope (%)	N/A	N/A	DWS Length (in)	N/A
		N/A	Landing X Slope (%)	N/A	N/A	DWS Full Width?	N/A
		N/A	Landing Curb? (Y/N)	N/A	N/A	DWS Offset (in)	N/A
		N/A	Shared Landing?	N/A			
		N/A	Gutter Ponding?	N/A	N/A	Gutter Slope (%)	N/A
		N/A	Gutter Lip Ht (in)	N/A	N/A	Gutter X Slope (%)	N/A
		N/A	Painted X Walk1?	No	N/A	Painted X Walk2?	No

X Walk 1 Direction	To N		X Walk 2 Direction	To W
		N/A	X Walk 1 Width (in)	N/A	N/A	X Walk 2 Width (in)	N/A
			X Walk 1 Slope (%)	8.1		X Walk 2 Slope (%)	0.9
			X Walk 1 X Slope (%)	0.5		X Walk 2 X Slope (%)	3.4
		N/A	Ramp inside XWalk1?	N/A	N/A	Ramp inside XWalk2?	N/A
			Road Slope (%)	1.1	N/A	Clear Space?	N/A
			Road X Slope (%)	5.5	N/A	Clear Space to XWalk (in)	N/A
		N/A	Any Obstructions?	N/A	N/A	Storm Grate/Utility Hazard?	N/A
			Obstruction Type			Storm Grate/Utility Type	
				N/A			N/A
					Yes	Surface Condition? (G/P)	Good
