# Access Compliance Report

## Public Rights-of-Way (Curb Ramps)

Intersection ID: 20390	Main Street: OLD_PINEVILLE_RD	Cross Street: GREENHILL_DR	Location: NW
ADA ID: 5BADD6D4E2B4	Ramp Type: Directional1	Initial Pass/Fail: Fail	Overall Compliance: No
Severity Score: 13.75			
Codes/Mitigation Info/Possible Solution		Field Measurements/Component Compliance

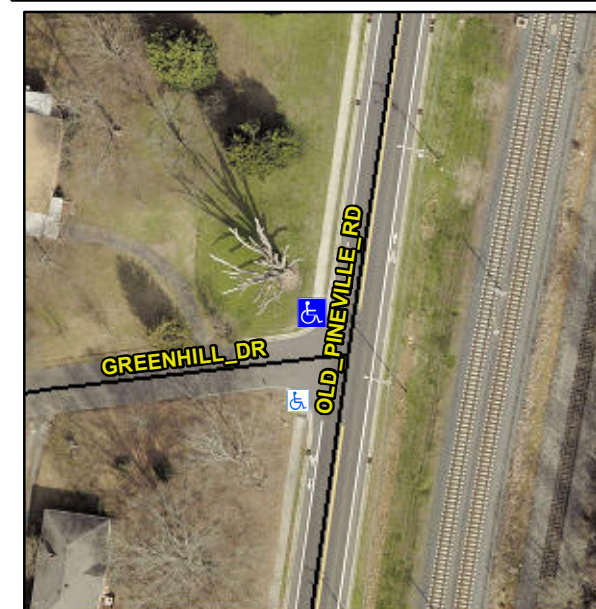
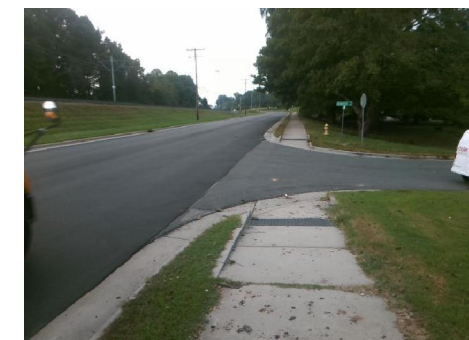
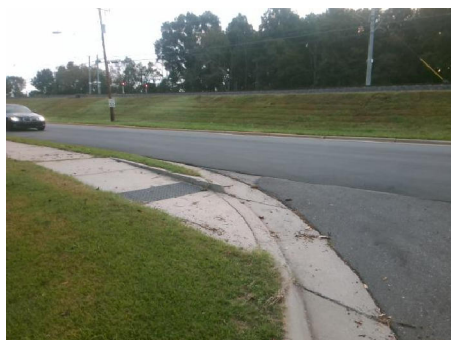
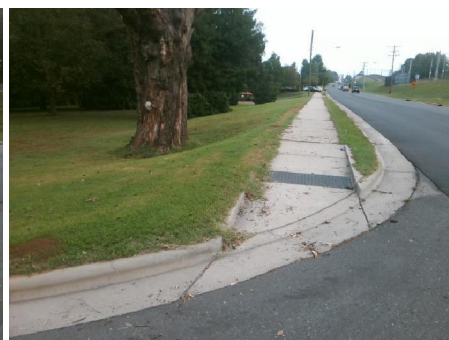
**R304.2.2, R304.5.3**

Compliance	Description	Data	Compliance	Description	Data
N/A	Ramp Length (in)	97.0	N/A	Grade Break?	N/A
Yes	Ramp Width (in)	67.0	N/A	Grade Break Slope (%)	0.0
No	Ramp Slope (%)	10.4	N/A	Grade Break XSlope (%)	0.0
No	Ramp XSlope (%)	2.3			
N/A	Flare Type LT	N/A	N/A	Flare Type RT	N/A
N/A	Flare Slope LT (%)	N/A	N/A	Flare Slope RT (%)	0.0
N/A	Flare Traversable LT?	N/A	N/A	Flare Traversable RT?	N/A
N/A	Landing Length (in)	0.0	N/A	DWS Provided?	N/A
N/A	Landing Width (in)	0.0	N/A	DWS Contrast?	N/A
N/A	Landing Slope (%)	0.0	N/A	DWS Length (in)	N/A
N/A	Landing X Slope (%)	0.0	N/A	DWS Full Width?	N/A
N/A	Landing Curb? (Y/N)	N/A	N/A	DWS Offset LT (in)	N/A
N/A	Shared Landing?	N/A	N/A	DWS Offset RT (in)	N/A
N/A	Gutter Ponding?	0.0	N/A	Gutter Slope (%)	N/A
N/A	Gutter Lip Ht (in)	0.0	N/A	Gutter X Slope (%)	N/A
N/A	Painted X Walk1?	No		Road Slope (%)	1.9
	X Walk 1 Direction	To S		Road X Slope (%)	10.2
	X Walk 1 Width (in)	N/A		Clear Space?	N/A

X Walk 1 Slope (%)	1.9	N/A	Clear Space to XWalk (in)	N/A
	X Walk 1 X Slope (%)	10.2	N/A	Storm Grate/Utility Hazard?	N/A
N/A	Ramp inside XWalk1?	N/A		Storm Grate/Utility Type	
N/A	Any Obstructions?	N/A			N/A
	Obstruction Type		Yes	Surface Condition? (G/P)	Good
			N/A	Curb Slope (%)	11.0

**Remove & Replace Entire Ramp.**

Total Cost: \$ 1600.00
