Access Compliance Report

Public Rights-of-Way

(Curb Ramps)

Intersection ID: 28674	Main Street: ARBORHILL_RD	Cross Street: WINTHROP RIDGE_RD	Location: SW
ADA ID: 5BB9727411CA	Ramp Type: Perp	Initial Pass/Fail: Fail	Overall Compliance: No
		Severity Score: 30

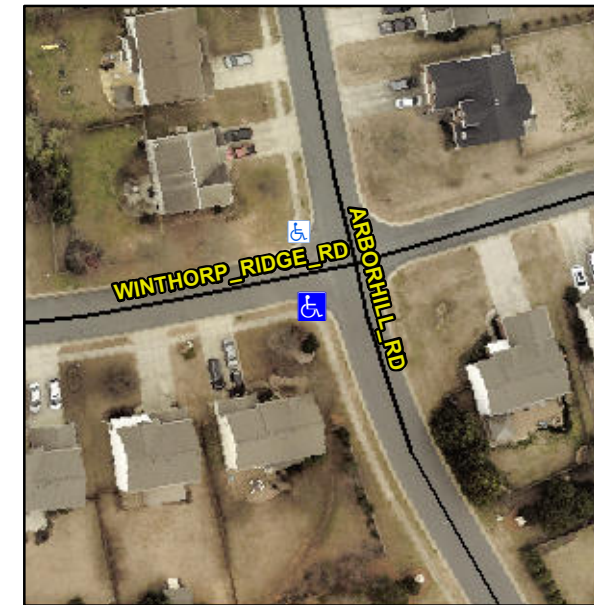
Not Found, R304.5.1, R304.5.3

Compliance	Description	Data	Compliance	Description	Data
N/A	Ramp Length (in)	48.0	Yes	Ramp Slope (%)	5.0
No	Ramp Width (in)	35.0	No	Ramp XSlope (%)	6.0
N/A	Flare Type LT	N/A	N/A	Flare Type RT	N/A
N/A	Flare Slope LT (%)	N/A	N/A	Flare Slope RT (%)	N/A
N/A	Flare Traversable LT?	N/A	N/A	Flare Traversable RT?	N/A
N/A	Landing Length (in)	N/A	N/A	DWS Provided?	N/A
N/A	Landing Width (in)	N/A	N/A	DWS Contrast?	N/A
N/A	Landing Slope (%)	N/A	N/A	DWS Length (in)	N/A
N/A	Landing X Slope (%)	N/A	N/A	DWS Full Width?	N/A
N/A	Landing Curb? (Y/N)	N/A	N/A	DWS Offset (in)	N/A
N/A	Shared Landing?	N/A			
N/A	Gutter Ponding?	N/A	N/A	Gutter Slope (%)	N/A
N/A	Gutter Lip Ht (in)	N/A	N/A	Gutter X Slope (%)	N/A
N/A	Painted X Walk1?	No	N/A	Painted X Walk2?	N/A
	X Walk 1 Direction	To N		X Walk 2 Direction	N/A
N/A	X Walk 1 Width (in)	N/A	N/A	X Walk 2 Width (in)	N/A
	X Walk 1 Slope (%)	0.5		X Walk 2 Slope (%)	N/A
	X Walk 1 X Slope (%)	3.6		X Walk 2 X Slope (%)	N/A

N/A	Ramp inside XWalk1?	N/A	N/A	Ramp inside XWalk2?	N/A
	Road Slope (%)	N/A	N/A	Clear Space?	N/A
	Road X Slope (%)	N/A	N/A	Clear Space to XWalk (in)	N/A
N/A	Any Obstructions?	N/A	N/A	Storm Grate/Utility Hazard?	N/A
	Obstruction Type			Storm Grate/Utility Type	
		N/A			N/A
			Yes	Surface Condition? (G/P)	Good

Possible Solutions:

Remove & Replace Entire Ramp.
