# Access Compliance Report

## Public Rights-of-Way

### (Curb Ramps)

Intersection ID: 16920	Main Street: IDLEWILD_RD	Cross Street: CEDARWILD_RD	Location: E
ADA ID: 5BC63A0970D9	Ramp Type: PerpDiag	Initial Pass/Fail: Fail	Overall Compliance: No
		Severity Score: 25

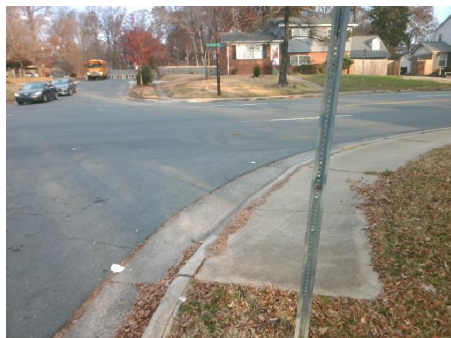
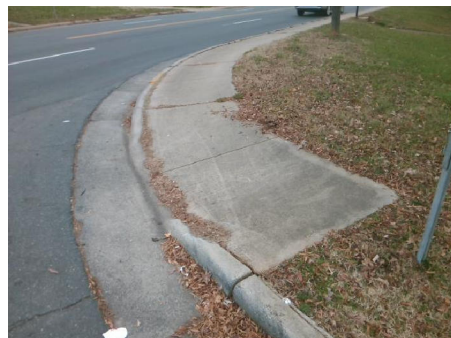
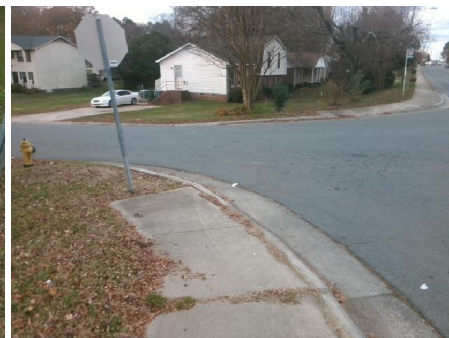
Compliance	Description	Data	Compliance	Description	Data
N/A	Ramp Length (in)	60.0	No	Ramp Slope (%)	8.6
Yes	Ramp Width (in)	48.0	No	Ramp XSlope (%)	6.6
N/A	Flare Type LT	N/A	N/A	Flare Type RT	N/A
N/A	Flare Slope LT (%)	N/A	N/A	Flare Slope RT (%)	N/A
N/A	Flare Traversable LT?	N/A	N/A	Flare Traversable RT?	N/A
N/A	Landing Length (in)	N/A	N/A	DWS Provided?	N/A
N/A	Landing Width (in)	N/A	N/A	DWS Contrast?	N/A
N/A	Landing Slope (%)	N/A	N/A	DWS Length (in)	N/A
N/A	Landing X Slope (%)	N/A	N/A	DWS Full Width?	N/A
N/A	Landing Curb? (Y/N)	N/A	N/A	DWS Offset (in)	N/A
N/A	Shared Landing?	N/A			
N/A	Gutter Ponding?	N/A	N/A	Gutter Slope (%)	N/A
N/A	Gutter Lip Ht (in)	N/A	N/A	Gutter X Slope (%)	N/A
N/A	Painted X Walk1?	No	N/A	Painted X Walk2?	No
	X Walk 1 Direction	To NW		X Walk 2 Direction	To SW
N/A	X Walk 1 Width (in)	N/A	N/A	X Walk 2 Width (in)	N/A
	X Walk 1 Slope (%)	3.9		X Walk 2 Slope (%)	1.3
	X Walk 1 X Slope (%)	0.4		X Walk 2 X Slope (%)	7.2

N/A	Ramp inside XWalk1?	N/A	N/A	Ramp inside XWalk2?	N/A
	Road Slope (%)	3.7	N/A	Clear Space?	N/A
	Road X Slope (%)	4.3	N/A	Clear Space to XWalk (in)	N/A
N/A	Any Obstructions?	N/A	N/A	Storm Grate/Utility Hazard?	N/A
	Obstruction Type			Storm Grate/Utility Type	
		N/A			N/A
			Yes	Surface Condition? (G/P)	Good

**Remove & Replace Curb Ramp With Two New Directional Ramps or Equivalent.**
