Access Compliance Report

Public Rights-of-Way

(Curb Ramps)

Intersection ID: 31523	Main Street: BACK_ACRE_DR	Cross Street: CALDWELL_RIDGE_PY	Location: W
ADA ID: 5BC6A8C83B84	Ramp Type: BlendTrans1	Initial Pass/Fail: Fail	Overall Compliance: No
Severity Score: 25			
Codes/Mitigation Info/Possible Solution		Field Measurements/Component Compliance

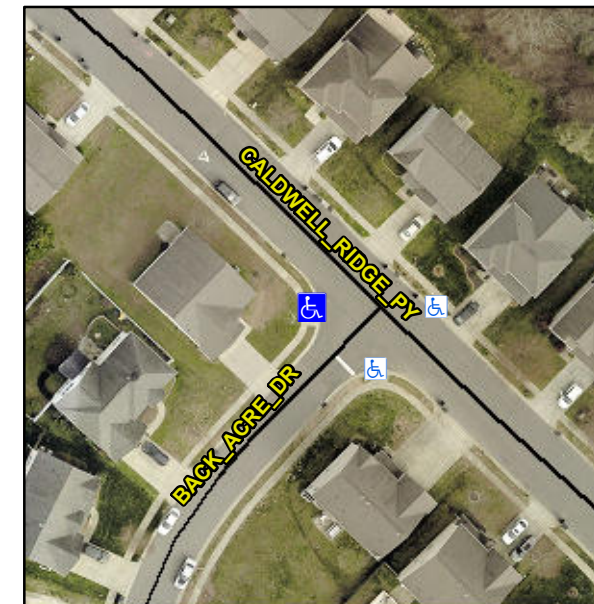
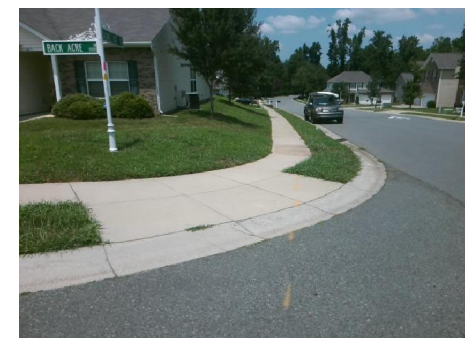
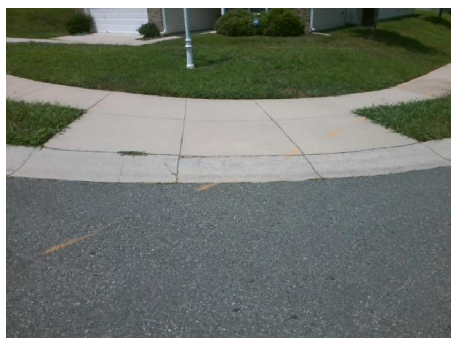
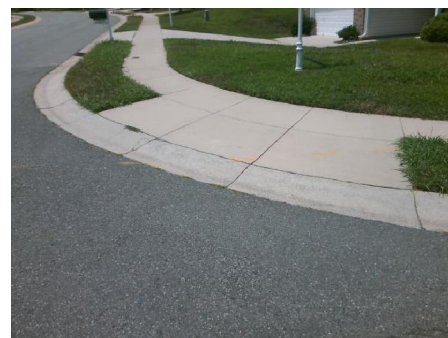
Compliance	Description	Data	Compliance	Description	Data
N/A	Ramp Length (in)	49.0	Yes	BlendTrans Slope (%)	3.8
Yes	Ramp Width (in)	52.0	No	BlendTrans XSlope (%)	7.5
N/A	Flare Type LT	N/A	N/A	Flare Type RT	N/A
N/A	Flare Slope LT (%)	N/A	N/A	Flare Slope RT (%)	N/A
N/A	Flare Traversable LT?	N/A	N/A	Flare Traversable RT?	N/A
N/A	Landing Length (in)	N/A	N/A	DWS Provided?	N/A
N/A	Landing Width (in)	N/A	N/A	DWS Contrast?	N/A
N/A	Landing Slope (%)	N/A	N/A	DWS Length (in)	N/A
N/A	Landing X Slope (%)	N/A	N/A	DWS Full Width?	N/A
N/A	Landing Curb? (Y/N)	N/A	N/A	DWS Offset (in)	N/A
N/A	Shared Landing?	N/A			
N/A	Gutter Ponding?	N/A	N/A	Gutter Slope (%)	N/A
N/A	Gutter Lip Ht (in)	N/A	N/A	Gutter X Slope (%)	N/A
N/A	Painted X Walk1?	No	N/A	Painted X Walk2?	No
	X Walk 1 Direction	To SE		X Walk 2 Direction	To NE
	X Walk 1 Width (in)	N/A		X Walk 2 Width (in)	N/A
	X Walk 1 Slope (%)	3.6		X Walk 2 Slope (%)	1.0
	X Walk 1 X Slope (%)	4.1		X Walk 2 X Slope (%)	7.1

N/A	Ramp inside XWalk1?	N/A	N/A	Ramp inside XWalk2?	N/A
	Road Slope (%)	6.1		Clear Space?	N/A
	Road X Slope (%)	3.7	N/A	Clear Space to XWalk (in)	N/A
N/A	Any Obstructions?	N/A	N/A	Storm Grate/Utility Hazard?	N/A
	Obstruction Type			Storm Grate/Utility Type	
		N/A			N/A
			Yes	Surface Condition? (G/P)	Good
			N/A	Curb Slope (%)	N/A

Remove & Replace Curb Ramp With Two New Directional Ramps or Equivalent.

R304.5.3

\$ 3200.00
