Intersection ID: N/A	Main Street: HARLEE_AV	Cross Street: N/A	Location:	N
ADA ID: 5BCD7B341D40	Ramp Type: PerpDiag	Initial Pass/Fail: Pass	Overall Compliance: No	Severity Score: 7.75

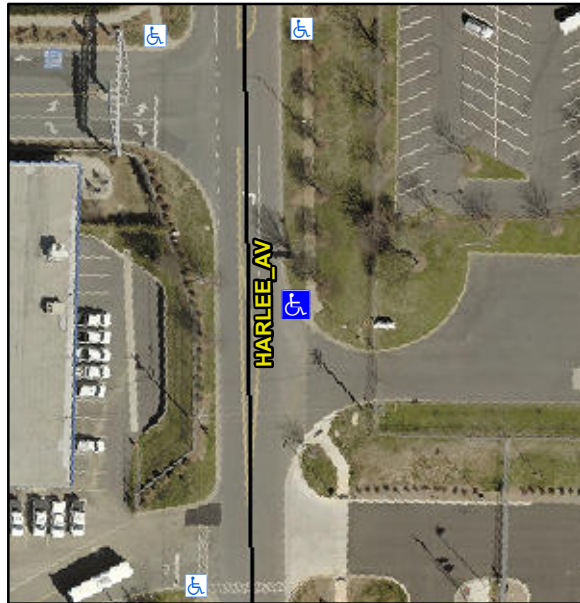
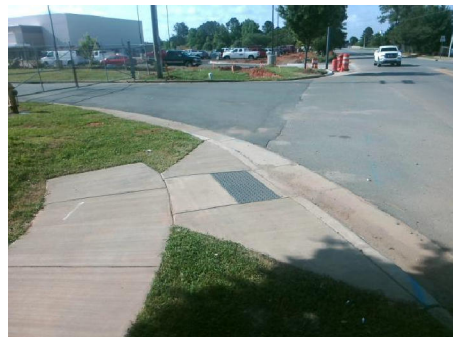
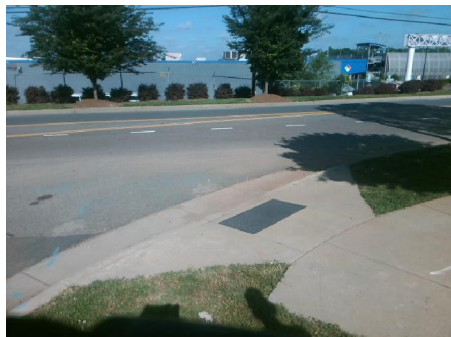
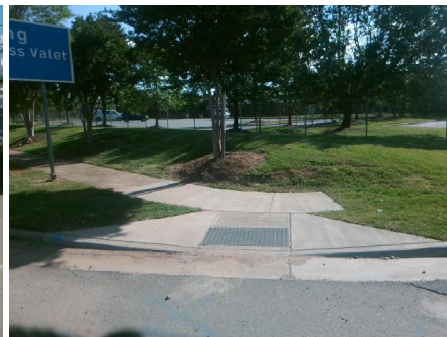
Compliance	Description	Data	Compliance	Description	Data
N/A	Ramp Length (in)	56.0	Yes	Ramp Slope (%)	5.1
Yes	Ramp Width (in)	48.0	No	Ramp XSlope (%)	2.3
N/A	Flare Type LT	Sloped	N/A	Flare Type RT	N/A
N/A	Flare Slope LT (%)	5.7	N/A	Flare Slope RT (%)	8.5
N/A	Flare Traversable LT?	No	N/A	Flare Traversable RT?	No
Yes	Landing Length (in)	60.0	Yes	DWS Provided?	Yes
Yes	Landing Width (in)	48.0	Yes	DWS Contrast?	Yes
No	Landing Slope (%)	2.7	Yes	DWS Length (in)	24.0
Yes	Landing X Slope (%)	0.7	Yes	DWS Full Width?	Yes
N/A	Landing Curb? (Y/N)	No	No	DWS Offset (in)	5.0
N/A	Shared Landing?	No			
Yes	Gutter Ponding?	No	Yes	Gutter Slope (%)	2.2
No	Gutter Lip Ht (in)	0.5	Yes	Gutter X Slope (%)	0.7
N/A	Painted X Walk1?	No	N/A	Painted X Walk2?	No
	X Walk 1 Direction	To W		X Walk 2 Direction	To S
N/A	X Walk 1 Width (in)	N/A	N/A	X Walk 2 Width (in)	N/A
	X Walk 1 Slope (%)	1.1		X Walk 2 Slope (%)	1.2
	X Walk 1 X Slope (%)	0.4		X Walk 2 X Slope (%)	0.0

N/A	Ramp inside XWalk1?	N/A	N/A	Ramp inside XWalk2?	N/A
	Road Slope (%)	0.2	N/A	Clear Space?	Yes
	Road X Slope (%)	0.2	N/A	Clear Space to XWalk (in)	N/A
Yes	Any Obstructions?	No	Yes	Storm Grate/Utility Hazard?	No
	Obstruction Type			Storm Grate/Utility Type	
		N/A			N/A
			Yes	Surface Condition? (G/P)	Good

Remove & Replace Curb Ramp With Two New Directional Ramps or Equivalent. Grind Gutter Lip.

R304.5.3, R304.2.2-Perp, R304.3.2-Para, R305.2, R302.7.2
