# Access Compliance Report

## Public Rights-of-Way

### (Curb Ramps)

Intersection ID: 46810	Main Street: ARBOR_VISTA_DR	Cross Street: CLAUDE_FREEMAN_DR	Location:	E
ADA ID: 5BDB53D1F295	Ramp Type: Combination1	Initial Pass/Fail: Fail	Overall Compliance: No	Severity Score: 35

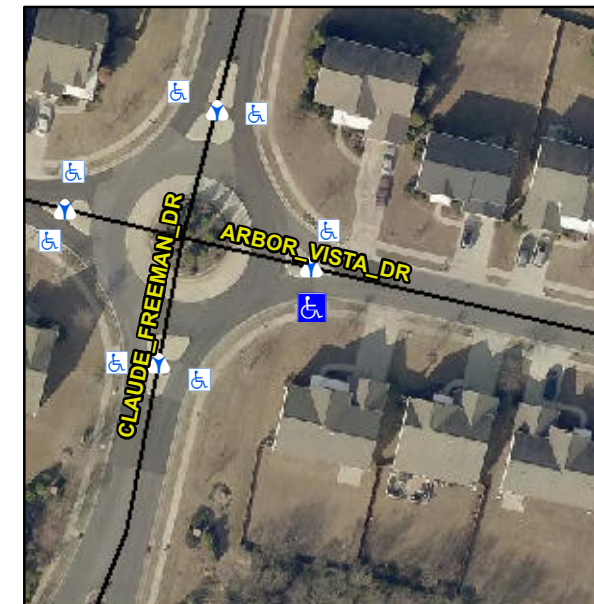
**RT RP < 5%**

**R304.5.1, R304.2.2, R304.5.3**

Compliance	Description	Data	Compliance	Description	Data
N/A	Ramp Length LT (in)	71.0	N/A	Ramp Length RT (in)	69.0
No	Ramp Width LT (in)	47.0	Yes	Ramp Width RT (in)	48.0
Yes	Ramp Slope LT (%)	5.4	Yes	Ramp Slope RT (%)	2.7
Yes	Ramp XSlope LT (%)	0.7	No	Ramp XSlope RT (%)	2.2
N/A	Ramp Length (in)	47.0	No	Ramp Slope (%)	15.9
Yes	Ramp Width (in)	55.0	No	Ramp XSlope (%)	3.6
N/A	Flare Type LT	N/A	N/A	Flare Type RT	N/A
N/A	Flare Slope LT (%)	N/A	N/A	Flare Slope RT (%)	N/A
N/A	Flare Traversable LT?	N/A	N/A	Flare Traversable RT?	N/A
N/A	Landing Length (in)	N/A	N/A	DWS Provided?	N/A
N/A	Landing Width (in)	N/A	N/A	DWS Contrast?	N/A
N/A	Landing Slope (%)	N/A	N/A	DWS Length (in)	N/A
N/A	Landing X Slope (%)	N/A	N/A	DWS Full Width?	N/A
N/A	Landing Curb? (Y/N)	N/A	N/A	DWS Offset (in)	N/A
N/A	Shared Landing?	N/A			
N/A	Gutter Ponding?	N/A	N/A	Gutter Slope (%)	N/A
N/A	Gutter Lip Ht (in)	N/A	N/A	Gutter X Slope (%)	N/A
N/A	Painted X Walk1?	No	N/A	Painted X Walk2?	N/A

**Remove & Replace Entire Ramp.**

Total Cost: \$ 1800.00
