Intersection ID: 15800	Main Street: PROVIDENCE_RD	Cross Street: QUEENS_RD	Location:	N
ADA ID: 5BDC40F0C3AB	Ramp Type: PerpDiag	Initial Pass/Fail: Fail	Overall Compliance: No	Severity Score: 33.75

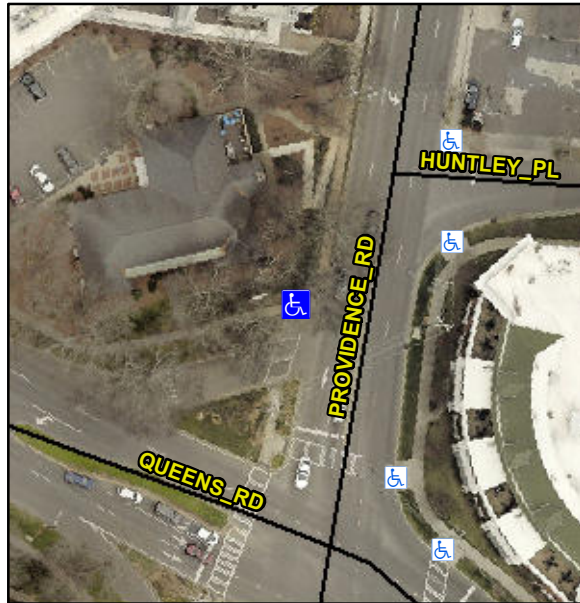
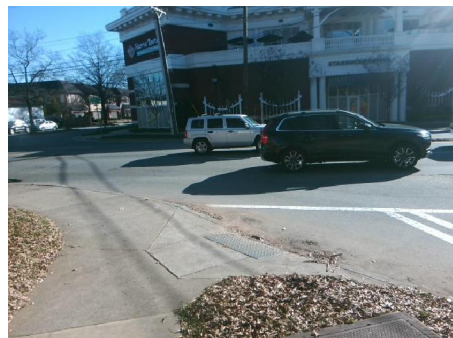
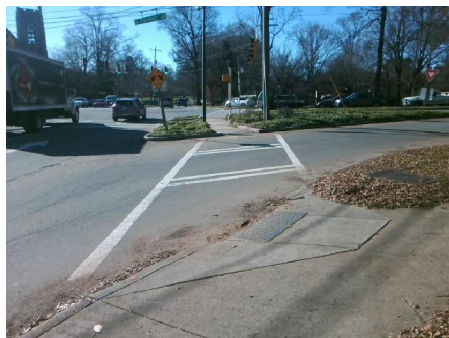
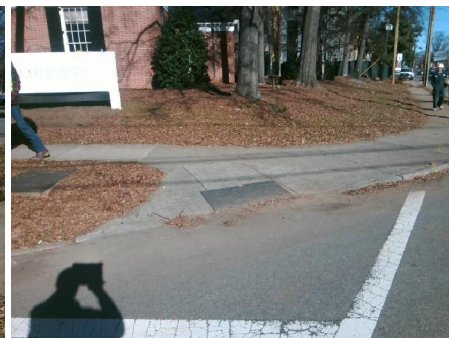
R304.5.1, R304.2.2

Compliance	Description	Data	Compliance	Description	Data
N/A	Ramp Length (in)	53.0	No	Ramp Slope (%)	17.9
No	Ramp Width (in)	40.0	Yes	Ramp XSlope (%)	1.5
N/A	Flare Type LT	N/A	N/A	Flare Type RT	N/A
N/A	Flare Slope LT (%)	N/A	N/A	Flare Slope RT (%)	N/A
N/A	Flare Traversable LT?	N/A	N/A	Flare Traversable RT?	N/A
N/A	Landing Length (in)	N/A	N/A	DWS Provided?	N/A
N/A	Landing Width (in)	N/A	N/A	DWS Contrast?	N/A
N/A	Landing Slope (%)	N/A	N/A	DWS Length (in)	N/A
N/A	Landing X Slope (%)	N/A	N/A	DWS Full Width?	N/A
N/A	Landing Curb? (Y/N)	N/A	N/A	DWS Offset (in)	N/A
N/A	Shared Landing?	N/A			
N/A	Gutter Ponding?	N/A	N/A	Gutter Slope (%)	N/A
N/A	Gutter Lip Ht (in)	N/A	N/A	Gutter X Slope (%)	N/A
N/A	Painted X Walk1?	Yes	N/A	Painted X Walk2?	No
	X Walk 1 Direction	To S		X Walk 2 Direction	To E
N/A	X Walk 1 Width (in)	113.0	N/A	X Walk 2 Width (in)	N/A
	X Walk 1 Slope (%)	0.7		X Walk 2 Slope (%)	0.0
	X Walk 1 X Slope (%)	0.3		X Walk 2 X Slope (%)	1.5

N/A	Ramp inside XWalk1?	Yes	N/A	Ramp inside XWalk2?	N/A
	Road Slope (%)	2.1	N/A	Clear Space?	N/A
	Road X Slope (%)	2.5	N/A	Clear Space to XWalk (in)	N/A
N/A	Any Obstructions?	N/A	N/A	Storm Grate/Utility Hazard?	N/A
	Obstruction Type			Storm Grate/Utility Type	
		N/A			N/A
			Yes	Surface Condition? (G/P)	Good

Remove & Replace Curb Ramp With Two New Directional Ramps or Equivalent.
