# Access Compliance Report

## Public Rights-of-Way

### (Curb Ramps)

| Intersection ID: 44115 | Main Street: RUTHERGLEN_CT | Cross Street: RIDING_HILL_AV | Location: SW |

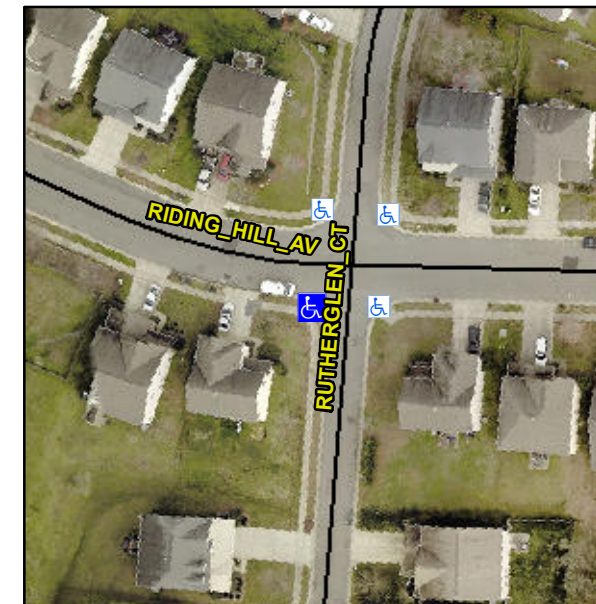
| ADA ID: 5BFA393A5CBA | Ramp Type: PerpDiag | Initial Pass/Fail: Fail | Overall Compliance: No |
| Severity Score: 42.5 | | | |

**Not Found, R304.5.1, R304.5.3**

| Compliance | Description | Data | Compliance | Description | Data |
|---|---|---|---|---|---|
| No | Ramp Width (in) | 34.5 | No | Ramp XSlope (%) | 10.5 |

**Remove & Replace Curb Ramp With Two New Directional Ramps or Equivalent.**

Total Cost: \$ 3200.00
