# Access Compliance Report

## Public Rights-of-Way

### (Curb Ramps)

Intersection ID: 10022596	Main Street: CARMEL_RD	Cross Street: N/A	Location: NE
ADA ID: 5BFACD9CD451	Ramp Type: Directional1	Initial Pass/Fail: Fail	Overall Compliance: No
Severity Score: 12.5			
Codes/Mitigation Info/Possible Solution		Field Measurements/Component Compliance

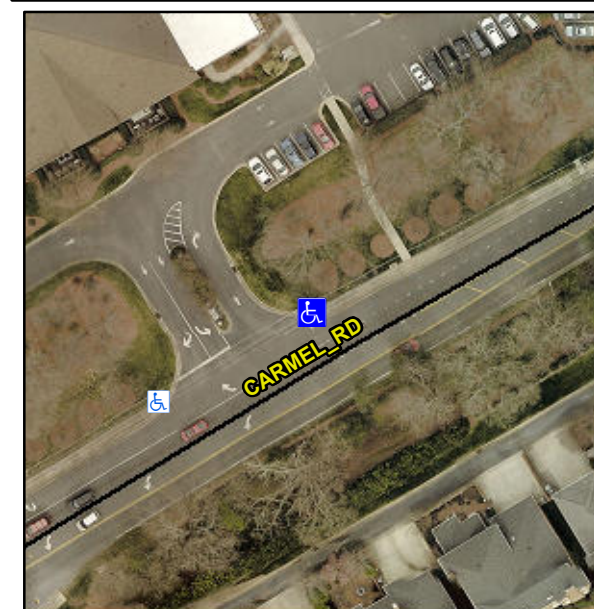
PROW/ADA:

**R304.2.2**

Compliance	Description	Data	Compliance	Description	Data
N/A	Ramp Length (in)	40.0	N/A	Grade Break?	N/A
Yes	Ramp Width (in)	49.0	N/A	Grade Break Slope (%)	0.0
No	Ramp Slope (%)	10.8	N/A	Grade Break XSlope (%)	0.0
Yes	Ramp XSlope (%)	2.0			
N/A	Flare Type LT	N/A	N/A	Flare Type RT	N/A
N/A	Flare Slope LT (%)	N/A	N/A	Flare Slope RT (%)	0.0
N/A	Flare Traversable LT?	N/A	N/A	Flare Traversable RT?	N/A
N/A	Landing Length (in)	0.0	N/A	DWS Provided?	N/A
N/A	Landing Width (in)	0.0	N/A	DWS Contrast?	N/A
N/A	Landing Slope (%)	0.0	N/A	DWS Length (in)	N/A
N/A	Landing X Slope (%)	0.0	N/A	DWS Full Width?	N/A
N/A	Landing Curb? (Y/N)	N/A	N/A	DWS Offset LT (in)	N/A
N/A	Shared Landing?	N/A	N/A	DWS Offset RT (in)	N/A
N/A	Gutter Ponding?	0.0	N/A	Gutter Slope (%)	N/A
N/A	Gutter Lip Ht (in)	0.0	N/A	Gutter X Slope (%)	N/A
N/A	Painted X Walk1?	No		Road Slope (%)	1.3
	X Walk 1 Direction	To SW		Road X Slope (%)	4.5
	X Walk 1 Width (in)	N/A		Clear Space?	N/A

X Walk 1 Slope (%)	1.3	N/A	Clear Space to XWalk (in)	N/A
	X Walk 1 X Slope (%)	4.5	N/A	Storm Grate/Utility Hazard?	N/A
N/A	Ramp inside XWalk1?	N/A		Storm Grate/Utility Type	
N/A	Any Obstructions?	N/A			N/A
	Obstruction Type		Yes	Surface Condition? (G/P)	Good
			N/A	Curb Slope (%)	2.9

Possible Solutions:

**Remove & Replace Entire Ramp.**

Total Cost: \$ 1600.00
