# Access Compliance Report

## Public Rights-of-Way

| Intersection ID: 10025931 | Main Street: ELLINGTON_PARK_DR | Cross Street: N/A | Location: NW |
| ADA ID: 5BFE7C1CED3D | Ramp Type: BlendTrans2 | Initial Pass/Fail: Fail | Overall Compliance: No |

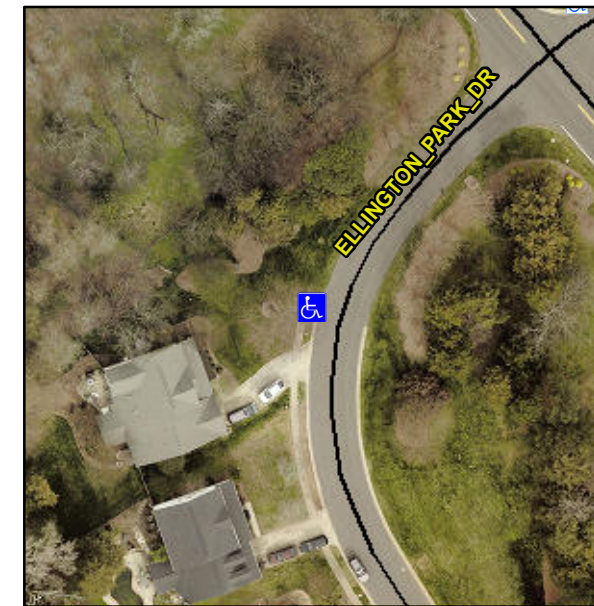
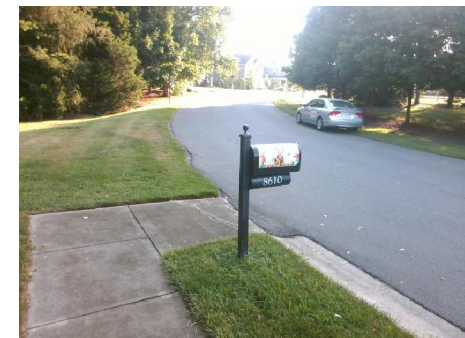
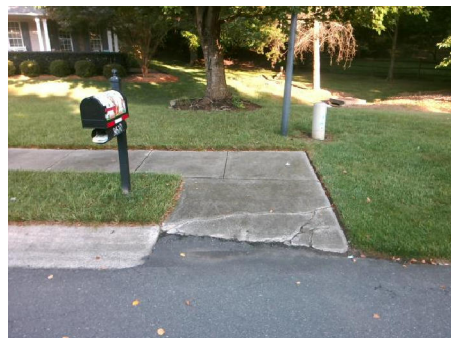
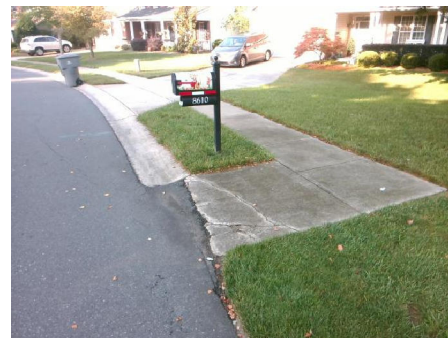
**Not Found, R302.7**

| Compliance | Description | Data | Compliance | Description | Data |
|---|---|---|---|---|---|
| | | | No | Surface Condition? (G/P) | Poor |
| | | | No | Curb Slope (%) | 17.4 |

**Remove & Replace Curb Ramp With Two New Directional Ramps or Equivalent.**

Total Cost: \$ 3200.00
