Access Compliance Report

Public Rights-of-Way

(Curb Ramps)

Intersection ID: 18040	Main Street: EAGLEWIND_DR	Cross Street: PINEY_GROVE_RD	Location: SE
ADA ID: 5C08241AE2B8	Ramp Type: PerpDiag	Initial Pass/Fail: Fail	Overall Compliance: No
Severity Score: 25			
Codes/Mitigation Info/Possible Solution		Field Measurements/Component Compliance

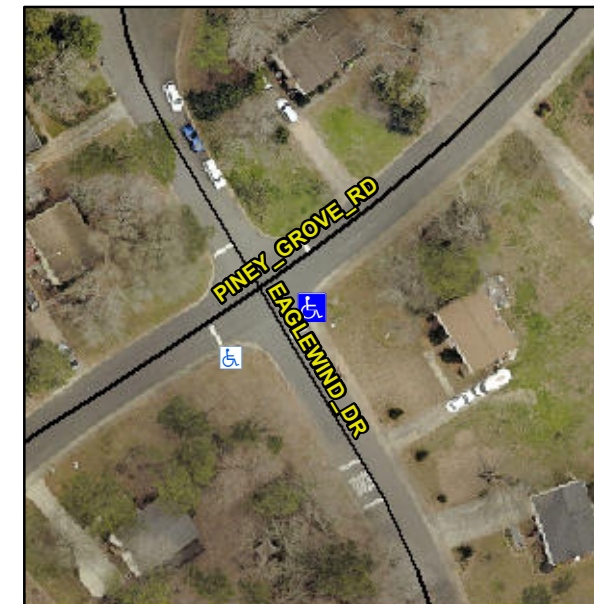
Not Found, R304.5.3

Compliance	Description	Data	Compliance	Description	Data
N/A	Ramp Length (in)	45.0	Yes	Ramp Slope (%)	5.8
Yes	Ramp Width (in)	48.0	No	Ramp XSlope (%)	7.1
N/A	Flare Type LT	N/A	N/A	Flare Type RT	N/A
N/A	Flare Slope LT (%)	N/A	N/A	Flare Slope RT (%)	N/A
N/A	Flare Traversable LT?	N/A	N/A	Flare Traversable RT?	N/A
N/A	Landing Length (in)	N/A	N/A	DWS Provided?	N/A
N/A	Landing Width (in)	N/A	N/A	DWS Contrast?	N/A
N/A	Landing Slope (%)	N/A	N/A	DWS Length (in)	N/A
N/A	Landing X Slope (%)	N/A	N/A	DWS Full Width?	N/A
N/A	Landing Curb? (Y/N)	N/A	N/A	DWS Offset (in)	N/A
N/A	Shared Landing?	N/A			
N/A	Gutter Ponding?	N/A	N/A	Gutter Slope (%)	N/A
N/A	Gutter Lip Ht (in)	N/A	N/A	Gutter X Slope (%)	N/A
N/A	Painted X Walk1?	No	N/A	Painted X Walk2?	No
	X Walk 1 Direction	To NW		X Walk 2 Direction	To SW
N/A	X Walk 1 Width (in)	N/A	N/A	X Walk 2 Width (in)	N/A
	X Walk 1 Slope (%)	1.5		X Walk 2 Slope (%)	0.2
	X Walk 1 X Slope (%)	3.3		X Walk 2 X Slope (%)	0.2

N/A	Ramp inside XWalk1?	N/A	N/A	Ramp inside XWalk2?	N/A
	Road Slope (%)	3.1	N/A	Clear Space?	N/A
	Road X Slope (%)	0.3	N/A	Clear Space to XWalk (in)	N/A
N/A	Any Obstructions?	N/A	N/A	Storm Grate/Utility Hazard?	N/A
	Obstruction Type			Storm Grate/Utility Type	
		N/A			N/A
			Yes	Surface Condition? (G/P)	Good

Remove & Replace Curb Ramp With Two New Directional Ramps or Equivalent.
