# Access Compliance Report

## Public Rights-of-Way

### (Curb Ramps)

Intersection ID: 49698	Main Street: LOUGHLIN_LN	Cross Street: MADISON_HILL_CT	Location: SE
ADA ID: 5C096B161F7D	Ramp Type: Perp	Initial Pass/Fail: Fail	Overall Compliance: No
Severity Score: 21.25			
Codes/Mitigation Info/Possible Solution		Field Measurements/Component Compliance

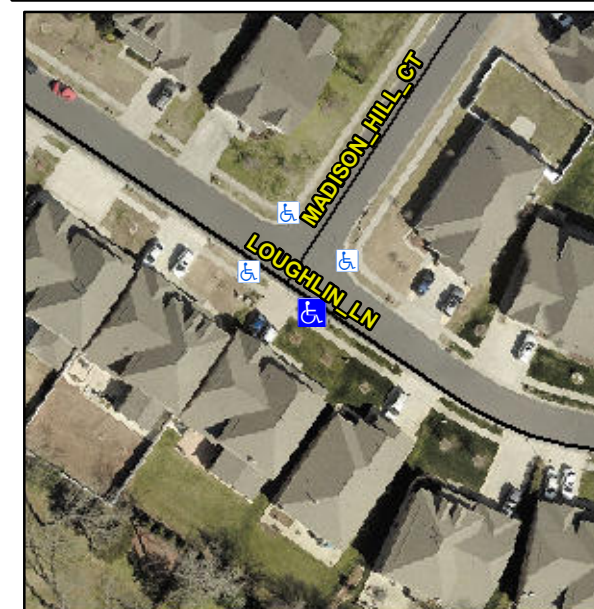
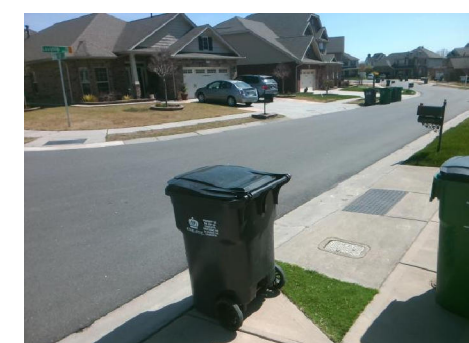
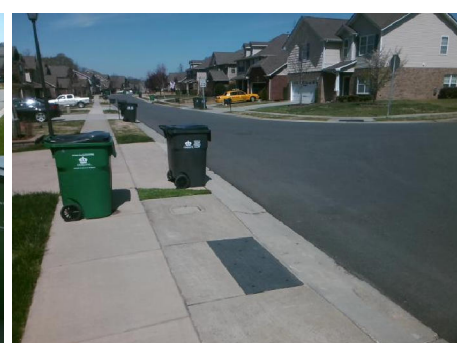
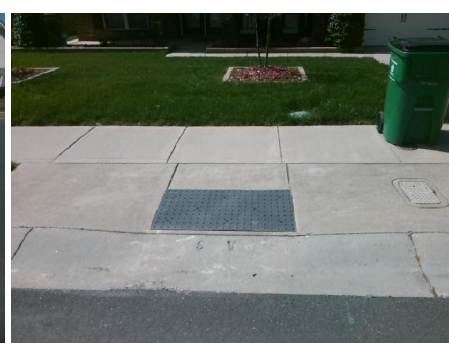
**Not Found, R304.5.1, R304.2.2**

Compliance	Description	Data	Compliance	Description	Data
N/A	Ramp Length (in)	47.0	No	Ramp Slope (%)	9.7
No	Ramp Width (in)	47.0	Yes	Ramp XSlope (%)	0.9
N/A	Flare Type LT	N/A	N/A	Flare Type RT	N/A
N/A	Flare Slope LT (%)	N/A	N/A	Flare Slope RT (%)	N/A
N/A	Flare Traversable LT?	N/A	N/A	Flare Traversable RT?	N/A
N/A	Landing Length (in)	N/A	N/A	DWS Provided?	N/A
N/A	Landing Width (in)	N/A	N/A	DWS Contrast?	N/A
N/A	Landing Slope (%)	N/A	N/A	DWS Length (in)	N/A
N/A	Landing X Slope (%)	N/A	N/A	DWS Full Width?	N/A
N/A	Landing Curb? (Y/N)	N/A	N/A	DWS Offset (in)	N/A
N/A	Shared Landing?	N/A			
N/A	Gutter Ponding?	N/A	N/A	Gutter Slope (%)	N/A
N/A	Gutter Lip Ht (in)	N/A	N/A	Gutter X Slope (%)	N/A
N/A	Painted X Walk1?	No	N/A	Painted X Walk2?	N/A
	X Walk 1 Direction	To NE		X Walk 2 Direction	N/A
N/A	X Walk 1 Width (in)	N/A	N/A	X Walk 2 Width (in)	N/A
	X Walk 1 Slope (%)	1.1		X Walk 2 Slope (%)	N/A
	X Walk 1 X Slope (%)	2.5		X Walk 2 X Slope (%)	N/A

N/A	Ramp inside XWalk1?	N/A	N/A	Ramp inside XWalk2?	N/A
	Road Slope (%)	N/A	N/A	Clear Space?	N/A
	Road X Slope (%)	N/A	N/A	Clear Space to XWalk (in)	N/A
N/A	Any Obstructions?	N/A	N/A	Storm Grate/Utility Hazard?	N/A
	Obstruction Type			Storm Grate/Utility Type	
		N/A			N/A
			Yes	Surface Condition? (G/P)	Good

**Remove & Replace Entire Ramp.**

Total Cost: \$ 1850.00
