# Access Compliance Report

## Public Rights-of-Way

### (Curb Ramps)

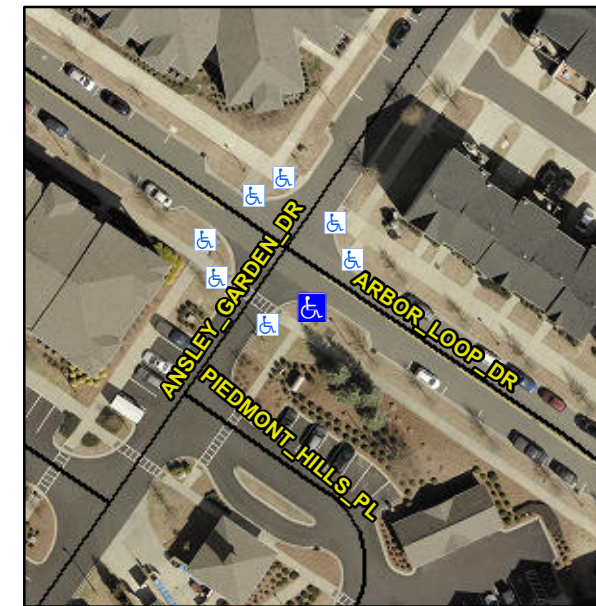
Intersection ID: N/A	Main Street: ARBOR_LOOP_DR	Cross Street: N/A	Location: S
ADA ID: 5C1DE17260BC	Ramp Type: Directional1	Initial Pass/Fail: Fail	Overall Compliance: No
Codes/Mitigation Info/Possible Solution		Field Measurements/Component Compliance	
Severity Score: 12.5

PROW/ADA:

**R304.2.2**

Compliance	Description	Data	Compliance	Description	Data
N/A	Ramp Length (in)	75.0	N/A	Grade Break?	N/A
Yes	Ramp Width (in)	57.0	N/A	Grade Break Slope (%)	0.0
No	Ramp Slope (%)	9.0	N/A	Grade Break XSlope (%)	0.0
Yes	Ramp XSlope (%)	0.8			
N/A	Flare Type LT	N/A	N/A	Flare Type RT	N/A
N/A	Flare Slope LT (%)	N/A	N/A	Flare Slope RT (%)	0.0
N/A	Flare Traversable LT?	N/A	N/A	Flare Traversable RT?	N/A
N/A	Landing Length (in)	0.0	N/A	DWS Provided?	N/A
N/A	Landing Width (in)	0.0	N/A	DWS Contrast?	N/A
N/A	Landing Slope (%)	0.0	N/A	DWS Length (in)	N/A
N/A	Landing X Slope (%)	0.0	N/A	DWS Full Width?	N/A
N/A	Landing Curb? (Y/N)	N/A	N/A	DWS Offset LT (in)	N/A
N/A	Shared Landing?	N/A	N/A	DWS Offset RT (in)	N/A
N/A	Gutter Ponding?	0.0	N/A	Gutter Slope (%)	N/A
N/A	Gutter Lip Ht (in)	0.0	N/A	Gutter X Slope (%)	N/A
N/A	Painted X Walk1?	No		Road Slope (%)	1.8
	X Walk 1 Direction	To NE		Road X Slope (%)	1.9
	X Walk 1 Width (in)	N/A		Clear Space?	N/A

X Walk 1 Slope (%)	1.8	N/A	Clear Space to XWalk (in)	N/A
	X Walk 1 X Slope (%)	1.9	N/A	Storm Grate/Utility Hazard?	N/A
N/A	Ramp inside XWalk1?	N/A		Storm Grate/Utility Type	
N/A	Any Obstructions?	N/A			N/A
	Obstruction Type		Yes	Surface Condition? (G/P)	Good
			N/A	Curb Slope (%)	4.2

Possible Solutions:

**Remove & Replace Entire Ramp.**

Total Cost: \$ 1600.00
