Access Compliance Report

Public Rights-of-Way

(Curb Ramps)

Intersection ID: 43206	Main Street: CALLAHAN_MILL_DR	Cross Street: ERWIN_TRACE_DR	Location: SE
ADA ID: 5C22E7E232F8	Ramp Type: BlendTrans2	Initial Pass/Fail: Fail	Overall Compliance: No
Severity Score: 10			
Codes/Mitigation Info/Possible Solution		Field Measurements/Component Compliance

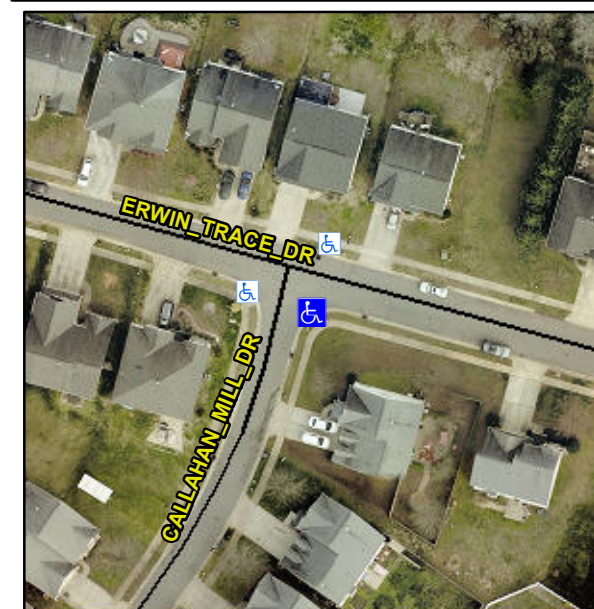
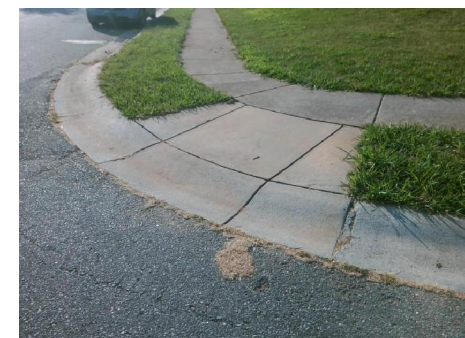
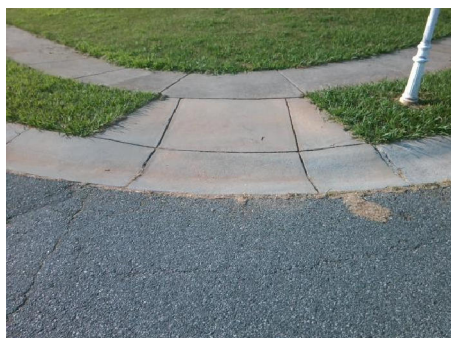
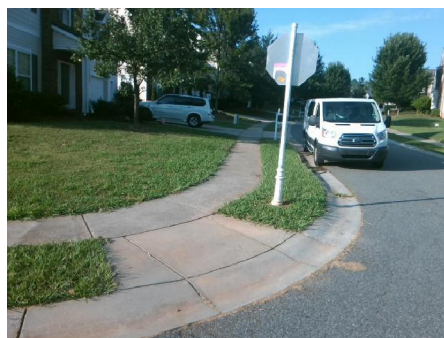
Compliance	Description	Data	Compliance	Description	Data
N/A	Ramp Length (in)	51.0	Yes	BlendTrans Slope (%)	4.7
No	Ramp Width (in)	47.5	No	BlendTrans XSlope (%)	4.3
N/A	Flare Type LT	N/A	N/A	Flare Type RT	N/A
N/A	Flare Slope LT (%)	N/A	N/A	Flare Slope RT (%)	N/A
N/A	Flare Traversable LT?	N/A	N/A	Flare Traversable RT?	N/A
N/A	Landing Length (in)	N/A	N/A	DWS Provided?	N/A
N/A	Landing Width (in)	N/A	N/A	DWS Contrast?	N/A
N/A	Landing Slope (%)	N/A	N/A	DWS Length (in)	N/A
N/A	Landing X Slope (%)	N/A	N/A	DWS Full Width?	N/A
N/A	Landing Curb? (Y/N)	N/A	N/A	DWS Offset (in)	N/A
N/A	Shared Landing?	N/A			
N/A	Gutter Ponding?	N/A	N/A	Gutter Slope (%)	N/A
N/A	Gutter Lip Ht (in)	N/A	N/A	Gutter X Slope (%)	N/A
N/A	Painted X Walk1?	No	N/A	Painted X Walk2?	No
	X Walk 1 Direction	To N		X Walk 2 Direction	To W
	X Walk 1 Width (in)	N/A		X Walk 2 Width (in)	N/A
	X Walk 1 Slope (%)	1.5		X Walk 2 Slope (%)	1.2
	X Walk 1 X Slope (%)	2.2		X Walk 2 X Slope (%)	3.2

N/A	Ramp inside XWalk1?	N/A	N/A	Ramp inside XWalk2?	N/A
	Road Slope (%)	3.5		Clear Space?	N/A
	Road X Slope (%)	0.2	N/A	Clear Space to XWalk (in)	N/A
N/A	Any Obstructions?	N/A	N/A	Storm Grate/Utility Hazard?	N/A
	Obstruction Type			Storm Grate/Utility Type	
		N/A			N/A
			Yes	Surface Condition? (G/P)	Good
			N/A	Curb Slope (%)	N/A

Remove & Replace Curb Ramp With Two New Directional Ramps or Equivalent.

R304.5.1, R304.5.3
