# Access Compliance Report

## Public Rights-of-Way

### (Curb Ramps)

| Intersection ID: 18383 | Main Street: FURMAN_PL | Cross Street: MURRAYHILL_RD | Location: NE |

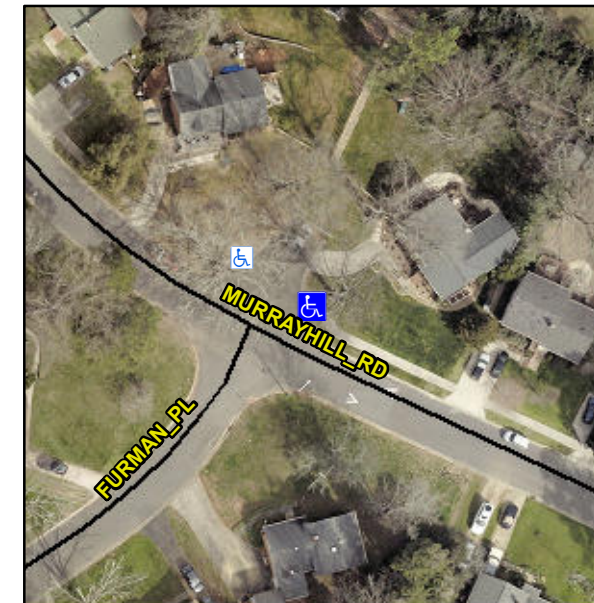
| ADA ID: 5C2CDB38E186 | Ramp Type: Directional1 | Initial Pass/Fail: Fail | Overall Compliance: No |
| | | Severity Score: 13.75 | |

| Compliance | Description | Data | Compliance | Description | Data |
|---|---|---|---|---|---|
| No | Ramp Slope (%) | 11.9 | N/A | Grade Break XSlope (%) | 0.0 |

**Remove & Replace Entire Ramp.**

**R304.2.2**

\$ 1600.00
