Access Compliance Report

Public Rights-of-Way

(Curb Ramps)

Intersection ID: 10759	Main Street: SPRATT_ST	Cross Street: OLIVER_ST	Location: NE
ADA ID: 5C4F36E2AFDF	Ramp Type: Perp	Initial Pass/Fail: Fail	Overall Compliance: No
		Severity Score: 10

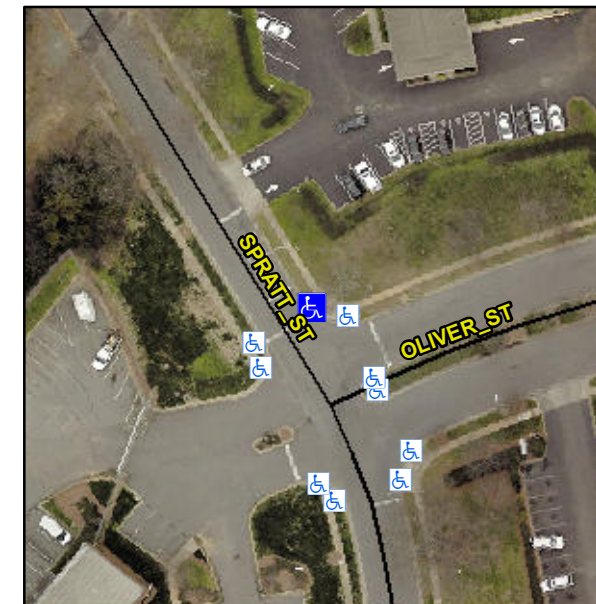
Not Found, R304.5.1, R304.5.3

Compliance	Description	Data	Compliance	Description	Data
N/A	Ramp Length (in)	114.5	Yes	Ramp Slope (%)	5.2
No	Ramp Width (in)	43.5	No	Ramp XSlope (%)	2.9
N/A	Flare Type LT	N/A	N/A	Flare Type RT	N/A
N/A	Flare Slope LT (%)	N/A	N/A	Flare Slope RT (%)	N/A
N/A	Flare Traversable LT?	N/A	N/A	Flare Traversable RT?	N/A
N/A	Landing Length (in)	N/A	N/A	DWS Provided?	N/A
N/A	Landing Width (in)	N/A	N/A	DWS Contrast?	N/A
N/A	Landing Slope (%)	N/A	N/A	DWS Length (in)	N/A
N/A	Landing X Slope (%)	N/A	N/A	DWS Full Width?	N/A
N/A	Landing Curb? (Y/N)	N/A	N/A	DWS Offset (in)	N/A
N/A	Shared Landing?	N/A			
N/A	Gutter Ponding?	N/A	N/A	Gutter Slope (%)	N/A
N/A	Gutter Lip Ht (in)	1.0	N/A	Gutter X Slope (%)	N/A
N/A	Painted X Walk1?	No	N/A	Painted X Walk2?	N/A
	X Walk 1 Direction	To SW		X Walk 2 Direction	N/A
N/A	X Walk 1 Width (in)	N/A	N/A	X Walk 2 Width (in)	N/A
	X Walk 1 Slope (%)	4.1		X Walk 2 Slope (%)	N/A
	X Walk 1 X Slope (%)	1.4		X Walk 2 X Slope (%)	N/A

Remove & Replace Entire Ramp.
