# Access Compliance Report

## Public Rights-of-Way

### (Curb Ramps)

| Intersection ID: 10016753 | Main Street: ORCHID_BRIDGE_RD | Cross Street: PUMPERNICKEL_RD | Location: W |

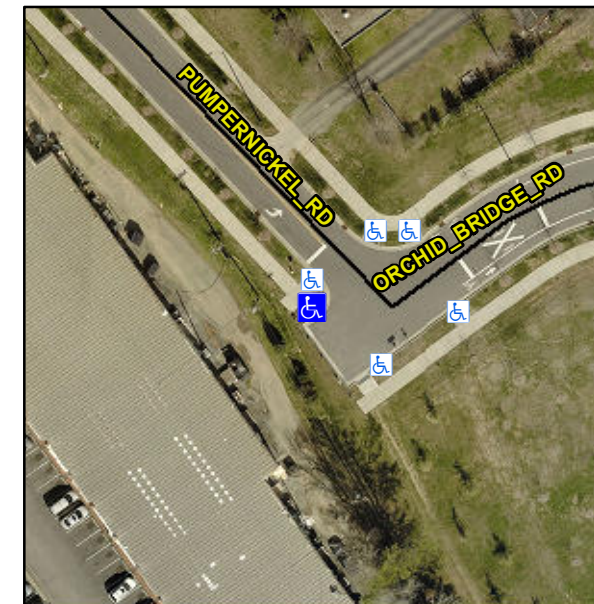
| ADA ID: 5C5B2DE2A3F5 | Ramp Type: BlendTrans1 | Initial Pass/Fail: Pass | Overall Compliance: No |

| Compliance | Description | Data | Compliance | Description | Data |
|---|---|---|---|---|---|
| Yes | Ramp Width (in) | 90.0 | No | BlendTrans XSlope (%) | 2.4 |
| No | Landing X Slope (%) | 3.9 | Yes | DWS Full Width? | Yes |
| N/A | Landing Curb? (Y/N) | No | No | DWS Offset (in) | 2.5 |
| Yes | Gutter Lip Ht (in) | 0.0 | No | Gutter X Slope (%) | 2.9 |

**Remove & Replace Curb Ramp With Two New Directional Ramps or Equivalent. Remove & Replace Gutter.**

**R304.5.3, R305.2**
