Access Compliance Report

Public Rights-of-Way

(Curb Ramps)

| Intersection ID: N/A | Main Street: ROLLINGWOOD_DR | Cross Street: FIELDCREST_RD | Location: NE |

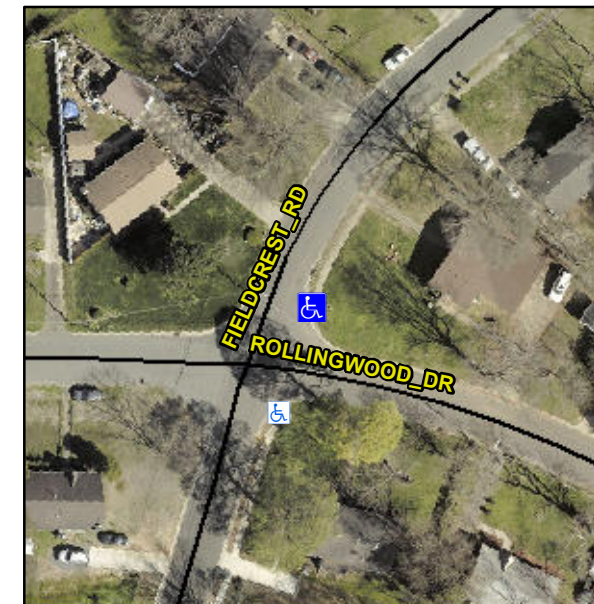
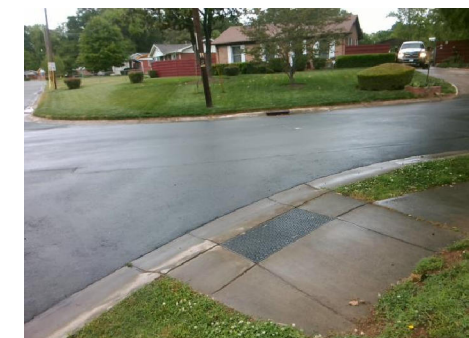
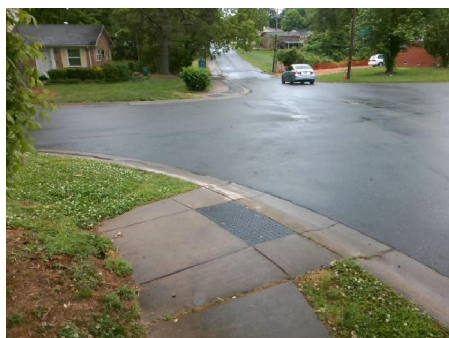
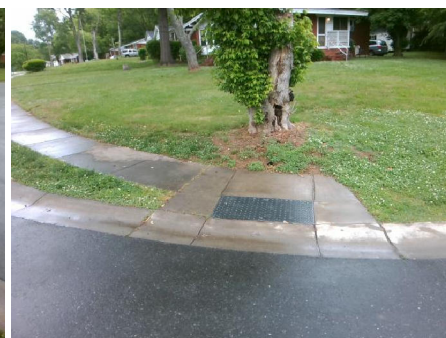
| ADA ID: 5C6D6CEE9542 | Ramp Type: PerpDiag | Initial Pass/Fail: Fail | Overall Compliance: No |
| Severity Score: 12.5 | | | |

Not Found, R304.5.3

| Compliance | Description | Data | Compliance | Description | Data |
|---|---|---|---|---|---|
| Yes | Ramp Width (in) | 48.0 | No | Ramp XSlope (%) | 5.8 |

Remove & Replace Curb Ramp With Two New Directional Ramps or Equivalent.

Total Cost: \$ 3200.00
