Access Compliance Report

Public Rights-of-Way

(Curb Ramps)

Intersection ID: 23217	Main Street: GLENEAGLES_RD	Cross Street: QUAIL_HOLLOW_RD	Location: NE
ADA ID: 5C812136F6B3	Ramp Type: Perp	Initial Pass/Fail: Fail	Overall Compliance: No
Severity Score: 25			
Codes/Mitigation Info/Possible Solution		Field Measurements/Component Compliance

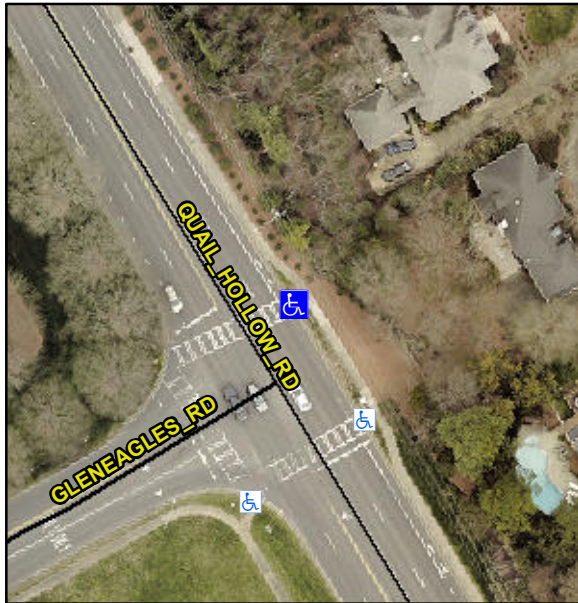
Not Found, R304.2.2, R304.5.3

Compliance	Description	Data	Compliance	Description	Data
N/A	Ramp Length (in)	65.0	No	Ramp Slope (%)	10.3
Yes	Ramp Width (in)	49.0	No	Ramp XSlope (%)	6.6
N/A	Flare Type LT	N/A	N/A	Flare Type RT	N/A
N/A	Flare Slope LT (%)	N/A	N/A	Flare Slope RT (%)	N/A
N/A	Flare Traversable LT?	N/A	N/A	Flare Traversable RT?	N/A
N/A	Landing Length (in)	N/A	N/A	DWS Provided?	N/A
N/A	Landing Width (in)	N/A	N/A	DWS Contrast?	N/A
N/A	Landing Slope (%)	N/A	N/A	DWS Length (in)	N/A
N/A	Landing X Slope (%)	N/A	N/A	DWS Full Width?	N/A
N/A	Landing Curb? (Y/N)	N/A	N/A	DWS Offset (in)	N/A
N/A	Shared Landing?	N/A			
N/A	Gutter Ponding?	N/A	N/A	Gutter Slope (%)	N/A
N/A	Gutter Lip Ht (in)	N/A	N/A	Gutter X Slope (%)	N/A
N/A	Painted X Walk1?	Yes	N/A	Painted X Walk2?	N/A
	X Walk 1 Direction	To W		X Walk 2 Direction	N/A
N/A	X Walk 1 Width (in)	111.0	N/A	X Walk 2 Width (in)	N/A
	X Walk 1 Slope (%)	8.7		X Walk 2 Slope (%)	N/A
	X Walk 1 X Slope (%)	3.5		X Walk 2 X Slope (%)	N/A

N/A	Ramp inside XWalk1?	Yes	N/A	Ramp inside XWalk2?	N/A
	Road Slope (%)	N/A	N/A	Clear Space?	N/A
	Road X Slope (%)	N/A	N/A	Clear Space to XWalk (in)	N/A
N/A	Any Obstructions?	N/A	N/A	Storm Grate/Utility Hazard?	N/A
	Obstruction Type			Storm Grate/Utility Type	
		N/A			N/A
			Yes	Surface Condition? (G/P)	Good

Remove & Replace Entire Ramp.
