# Access Compliance Report

## Public Rights-of-Way

### (Curb Ramps)

Intersection ID: 42756	Main Street: CALDWELL_FOREST_DR	Cross Street: CALDWELL_RIDGE_PY	Location: NE
ADA ID: 5C87A82C88E4	Ramp Type: PerpDiag	Initial Pass/Fail: Fail	Overall Compliance: No
		Severity Score: 50

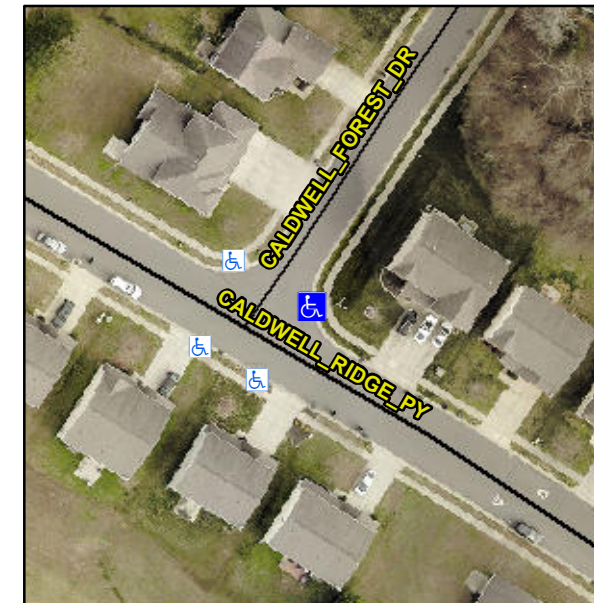
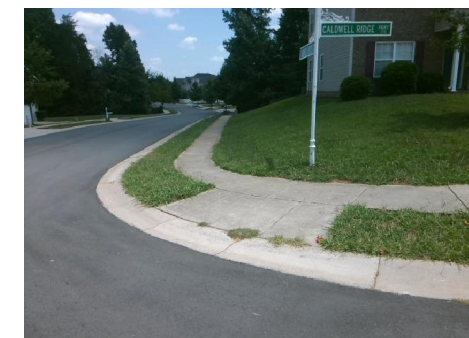
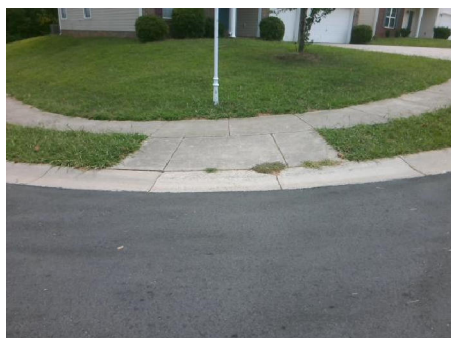
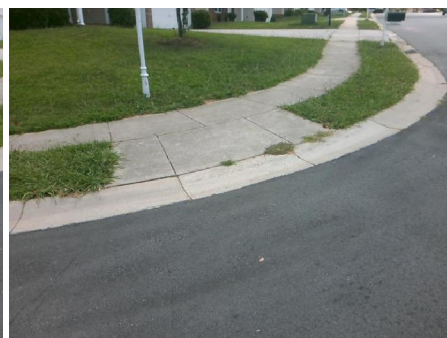
**Not Found, R304.2.2, R304.5.3**

Compliance	Description	Data	Compliance	Description	Data
N/A	Ramp Length (in)	47.0	No	Ramp Slope (%)	13.2
Yes	Ramp Width (in)	56.0	No	Ramp XSlope (%)	7.6
N/A	Flare Type LT	N/A	N/A	Flare Type RT	N/A
N/A	Flare Slope LT (%)	N/A	N/A	Flare Slope RT (%)	N/A
N/A	Flare Traversable LT?	N/A	N/A	Flare Traversable RT?	N/A
N/A	Landing Length (in)	N/A	N/A	DWS Provided?	N/A
N/A	Landing Width (in)	N/A	N/A	DWS Contrast?	N/A
N/A	Landing Slope (%)	N/A	N/A	DWS Length (in)	N/A
N/A	Landing X Slope (%)	N/A	N/A	DWS Full Width?	N/A
N/A	Landing Curb? (Y/N)	N/A	N/A	DWS Offset (in)	N/A
N/A	Shared Landing?	N/A			
N/A	Gutter Ponding?	N/A	N/A	Gutter Slope (%)	N/A
N/A	Gutter Lip Ht (in)	N/A	N/A	Gutter X Slope (%)	N/A
N/A	Painted X Walk1?	No	N/A	Painted X Walk2?	No
	X Walk 1 Direction	To NW		X Walk 2 Direction	To SW
N/A	X Walk 1 Width (in)	N/A	N/A	X Walk 2 Width (in)	N/A
	X Walk 1 Slope (%)	1.6		X Walk 2 Slope (%)	7.0
	X Walk 1 X Slope (%)	5.8		X Walk 2 X Slope (%)	5.9

N/A	Ramp inside XWalk1?	N/A	N/A	Ramp inside XWalk2?	N/A
	Road Slope (%)	6.5	N/A	Clear Space?	N/A
	Road X Slope (%)	2.3	N/A	Clear Space to XWalk (in)	N/A
N/A	Any Obstructions?	N/A	N/A	Storm Grate/Utility Hazard?	N/A
	Obstruction Type			Storm Grate/Utility Type	
		N/A			N/A
			Yes	Surface Condition? (G/P)	Good

**Remove & Replace Curb Ramp With Two New Directional Ramps or Equivalent.**
