# Access Compliance Report

## Public Rights-of-Way

### (Curb Ramps)

Intersection ID: 12527	Main Street: E_7TH_ST	Cross Street: N_DAVIDSON_ST	Location: E
ADA ID: 5C89E388442B	Ramp Type: PerpDiag	Initial Pass/Fail: Fail	Overall Compliance: No
Severity Score: 8.75			
Codes/Mitigation Info/Possible Solution		Field Measurements/Component Compliance

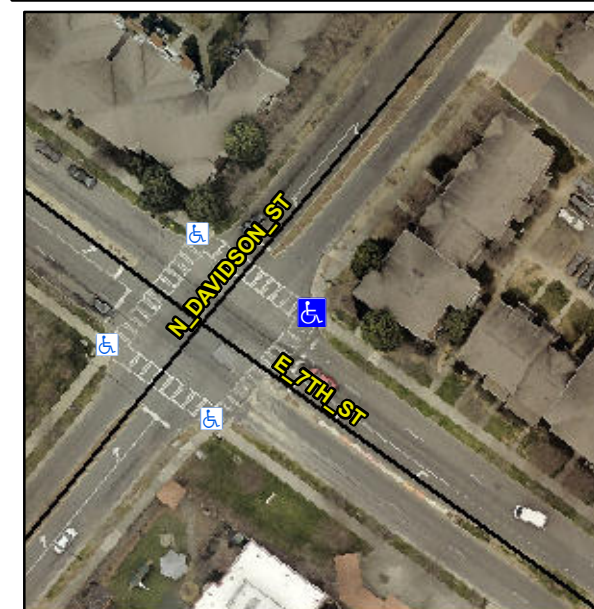
Compliance	Description	Data	Compliance	Description	Data
N/A	Ramp Length (in)	78.0	Yes	Ramp Slope (%)	5.0
No	Ramp Width (in)	39.0	Yes	Ramp XSlope (%)	1.7
N/A	Flare Type LT	N/A	N/A	Flare Type RT	N/A
N/A	Flare Slope LT (%)	N/A	N/A	Flare Slope RT (%)	N/A
N/A	Flare Traversable LT?	N/A	N/A	Flare Traversable RT?	N/A
N/A	Landing Length (in)	N/A	N/A	DWS Provided?	N/A
N/A	Landing Width (in)	N/A	N/A	DWS Contrast?	N/A
N/A	Landing Slope (%)	N/A	N/A	DWS Length (in)	N/A
N/A	Landing X Slope (%)	N/A	N/A	DWS Full Width?	N/A
N/A	Landing Curb? (Y/N)	N/A	N/A	DWS Offset (in)	N/A
N/A	Shared Landing?	N/A			
N/A	Gutter Ponding?	N/A	N/A	Gutter Slope (%)	N/A
N/A	Gutter Lip Ht (in)	N/A	N/A	Gutter X Slope (%)	N/A
N/A	Painted X Walk1?	Yes	N/A	Painted X Walk2?	Yes
	X Walk 1 Direction	To NW		X Walk 2 Direction	To SW
N/A	X Walk 1 Width (in)	110.0	N/A	X Walk 2 Width (in)	110.5
	X Walk 1 Slope (%)	2.3		X Walk 2 Slope (%)	0.5
	X Walk 1 X Slope (%)	2.6		X Walk 2 X Slope (%)	1.2

N/A	Ramp inside XWalk1?	Yes	N/A	Ramp inside XWalk2?	Yes
	Road Slope (%)	0.5	N/A	Clear Space?	N/A
	Road X Slope (%)	1.0	N/A	Clear Space to XWalk (in)	N/A
N/A	Any Obstructions?	N/A	N/A	Storm Grate/Utility Hazard?	N/A
	Obstruction Type			Storm Grate/Utility Type	
		N/A			N/A
		Yes		Surface Condition? (G/P)	Good

Possible Solutions:

**Remove & Replace Curb Ramp With Two New Directional Ramps or Equivalent.**

**R304.5.1**
