Access Compliance Report Public Rights-of-Way (Curb Ramps)

Intersection ID: N/A Main Street: TUCKASEEGEE_RD Cross Street: N_I-85_RA Location: SE

ADA ID: 5C8A2BE3EBA0 Ramp Type: Directional1 Initial Pass/Fail: Fail Overall Compliance: No Severity Score: 37.5

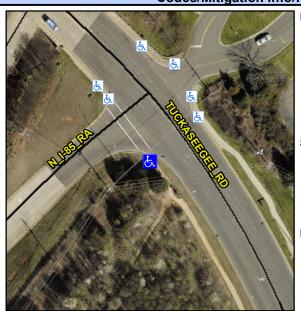
Field Measurements/Component Compliance						
Comp	liance Description	Data	Comp	liance Description	Data	
N/A	Ramp Length (in)	135.5	N/A	Grade Break?	N/A	
Yes	Ramp Width (in)	61.0	N/A	Grade Break Slope (%)	0.0	
No	Ramp Slope (%)	12.4	N/A	Grade Break XSlope (%)	0.0	
No	Ramp XSlope (%)	5.7				
N/A	Flare Type LT	N/A	N/A	Flare Type RT	N/A	
N/A	Flare Slope LT (%)	N/A	N/A	Flare Slope RT (%)	0.0	
N/A	Flare Traversable LT?	N/A	N/A	Flare Traversable RT?	N/A	
N/A	Landing Length (in)	0.0	N/A	DWS Provided?	N/A	
N/A	Landing Width (in)	0.0	N/A	DWS Contrast?	N/A	
N/A	Landing Slope (%)	0.0	N/A	DWS Length (in)	N/A	
N/A	Landing X Slope (%)	0.0	N/A	DWS Full Width?	N/A	
N/A	Landing Curb? (Y/N)	N/A	N/A	DWS Offset LT (in)	N/A	
N/A	Shared Landing?	N/A	N/A	DWS Offset RT (in)	N/A	
N/A	Gutter Ponding?	0.0	N/A	Gutter Slope (%)	N/A	
N/A	Gutter Lip Ht (in)	0.0	N/A	Gutter X Slope (%)	N/A	
N/A	Painted X Walk1?	Yes		Road Slope (%)	6.9	
	X Walk 1 Direction	To NW		Road X Slope (%)	5.9

X Walk 1 Width (in)	112.0		Clear Space?	N/A	
	X Walk 1 Slope (%)	6.9	N/A	Clear Space to XWalk (in)	N/A	
	X Walk 1 X Slope (%)	5.9	N/A	Storm Grate/Utility Hazard?	N/A	
N/A	Ramp inside XWalk1?	Yes		Storm Grate/Utility Type		
N/A	Any Obstructions?	N/A			N/A	
	Obstruction Type		Yes	Surface Condition? (G/P)	Good	
		N/A	N/A	Curb Slope (%)	1.6

Possible Solution	
Possible Solutions:	Col
Remove & Replace Entire Ramp.	N/A
·	Yes
	No
	No
	N/A
	N/A
Surveyor Notes:	N/A
PONDING	N/A
	N/A
	N/A
	N/A
PROW/ADA:	N/A
R304.2.2, R304.5.3	N/A
	N/A
	N/A
	N/A
