Access Compliance Report

Public Rights-of-Way

(Curb Ramps)

Intersection ID: 3033	Main Street: DEARMON_RD	Cross Street: BENFIELD RD	Location:	N
ADA ID: 5C8AF0BC5FA9	Ramp Type: Perp	Initial Pass/Fail: Fail	Overall Compliance: No	Severity Score: 25

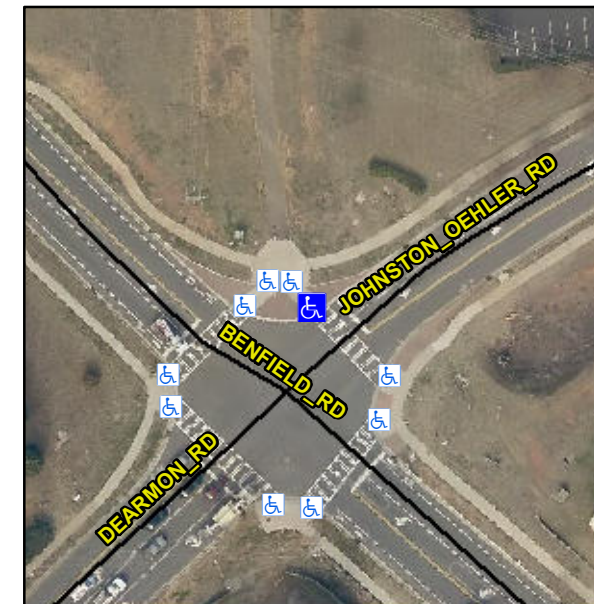
Compliance	Description	Data	Compliance	Description	Data
N/A	Ramp Length (in)	179.5	No	Ramp Slope (%)	20.0
Yes	Ramp Width (in)	53.0	Yes	Ramp XSlope (%)	0.3
N/A	Flare Type LT	N/A	N/A	Flare Type RT	N/A
N/A	Flare Slope LT (%)	N/A	N/A	Flare Slope RT (%)	N/A
N/A	Flare Traversable LT?	N/A	N/A	Flare Traversable RT?	N/A
N/A	Landing Length (in)	N/A	N/A	DWS Provided?	N/A
N/A	Landing Width (in)	N/A	N/A	DWS Contrast?	N/A
N/A	Landing Slope (%)	N/A	N/A	DWS Length (in)	N/A
N/A	Landing X Slope (%)	N/A	N/A	DWS Full Width?	N/A
N/A	Landing Curb? (Y/N)	N/A	N/A	DWS Offset (in)	N/A
N/A	Shared Landing?	N/A			
N/A	Gutter Ponding?	N/A	N/A	Gutter Slope (%)	N/A
N/A	Gutter Lip Ht (in)	N/A	N/A	Gutter X Slope (%)	N/A
N/A	Painted X Walk1?	No	N/A	Painted X Walk2?	N/A
	X Walk 1 Direction	To SE		X Walk 2 Direction	N/A
N/A	X Walk 1 Width (in)	111.5	N/A	X Walk 2 Width (in)	N/A
	X Walk 1 Slope (%)	1.9		X Walk 2 Slope (%)	N/A
	X Walk 1 X Slope (%)	0.3		X Walk 2 X Slope (%)	N/A

N/A	Ramp inside XWalk1?	N/A	N/A	Ramp inside XWalk2?	N/A
	Road Slope (%)	N/A	N/A	Clear Space?	N/A
	Road X Slope (%)	N/A	N/A	Clear Space to XWalk (in)	N/A
N/A	Any Obstructions?	N/A	N/A	Storm Grate/Utility Hazard?	N/A
	Obstruction Type			Storm Grate/Utility Type	
		N/A			N/A
			Yes	Surface Condition? (G/P)	Good

Remove & Replace Entire Ramp.

R304.2.2
