# Access Compliance Report

## Public Rights-of-Way

### (Curb Ramps)

Intersection ID: 8835	Main Street: BRADFORD_DR	Cross Street: NORTH_AV	Location: SE
ADA ID: 5C9675B3033D	Ramp Type: Perp	Initial Pass/Fail: Fail	Overall Compliance: No
		Severity Score: 50

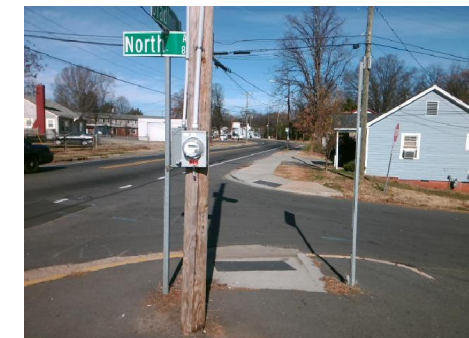
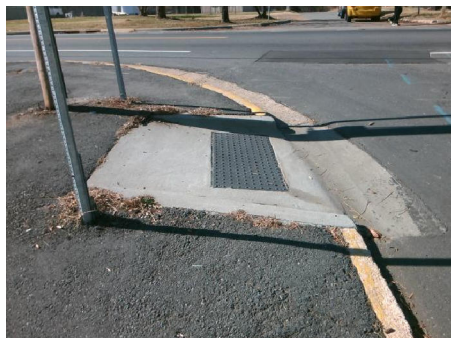
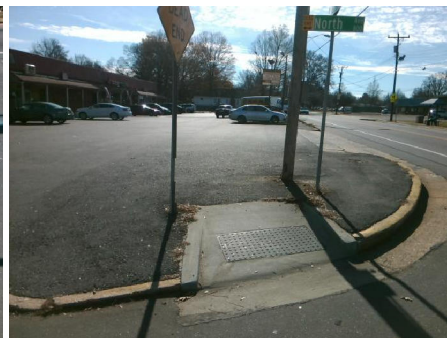
**Not Found, R304.2.2, R304.5.3**

Compliance	Description	Data	Compliance	Description	Data
N/A	Ramp Length (in)	73.0	No	Ramp Slope (%)	14.3
Yes	Ramp Width (in)	48.0	No	Ramp XSlope (%)	7.2
N/A	Flare Type LT	N/A	N/A	Flare Type RT	N/A
N/A	Flare Slope LT (%)	N/A	N/A	Flare Slope RT (%)	N/A
N/A	Flare Traversable LT?	N/A	N/A	Flare Traversable RT?	N/A
N/A	Landing Length (in)	N/A	N/A	DWS Provided?	N/A
N/A	Landing Width (in)	N/A	N/A	DWS Contrast?	N/A
N/A	Landing Slope (%)	N/A	N/A	DWS Length (in)	N/A
N/A	Landing X Slope (%)	N/A	N/A	DWS Full Width?	N/A
N/A	Landing Curb? (Y/N)	N/A	N/A	DWS Offset (in)	N/A
N/A	Shared Landing?	N/A			
N/A	Gutter Ponding?	N/A	N/A	Gutter Slope (%)	N/A
N/A	Gutter Lip Ht (in)	N/A	N/A	Gutter X Slope (%)	N/A
N/A	Painted X Walk1?	No	N/A	Painted X Walk2?	N/A
	X Walk 1 Direction	To N		X Walk 2 Direction	N/A
N/A	X Walk 1 Width (in)	N/A	N/A	X Walk 2 Width (in)	N/A
	X Walk 1 Slope (%)	4.9		X Walk 2 Slope (%)	N/A
	X Walk 1 X Slope (%)	8.8		X Walk 2 X Slope (%)	N/A

**Remove & Replace Entire Ramp.**
