Access Compliance Report

Public Rights-of-Way

(Curb Ramps)

Intersection ID: 11446	Main Street: GRACE_ST	Cross Street: PEGRAM_ST	Location: SE
ADA ID: 5C9CA99E529C	Ramp Type: BlendTrans2	Initial Pass/Fail: Pass	Overall Compliance: No
		Severity Score: 15

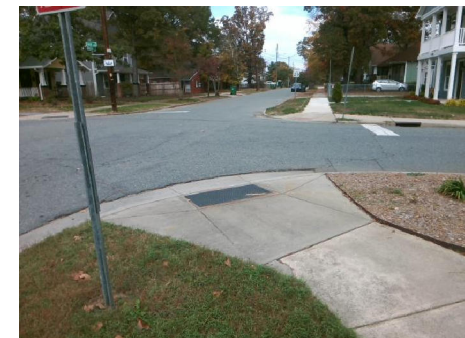
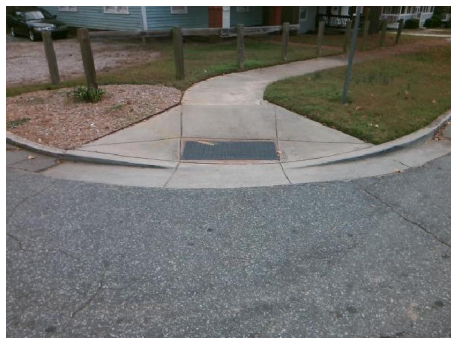
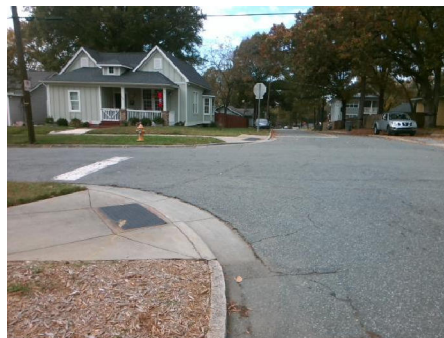
Not Found, R305.2, R302.7.2

Compliance	Description	Data	Compliance	Description	Data
N/A	Ramp Length (in)	30.0	Yes	BlendTrans Slope (%)	0.1
Yes	Ramp Width (in)	48.0	Yes	BlendTrans XSlope (%)	1.1
N/A	Flare Type LT	Sloped	N/A	Flare Type RT	Sloped
N/A	Flare Slope LT (%)	N/A	N/A	Flare Slope RT (%)	N/A
N/A	Flare Traversable LT?	No	N/A	Flare Traversable RT?	No
N/A	Landing Length (in)	N/A	Yes	DWS Provided?	Yes
N/A	Landing Width (in)	N/A	Yes	DWS Contrast?	Yes
N/A	Landing Slope (%)	N/A	Yes	DWS Length (in)	24.0
N/A	Landing X Slope (%)	N/A	Yes	DWS Full Width?	Yes
N/A	Landing Curb? (Y/N)	No	No	DWS Offset (in)	4.0
N/A	Shared Landing?	No			
Yes	Gutter Ponding?	No	Yes	Gutter Slope (%)	3.8
No	Gutter Lip Ht (in)	1.0	Yes	Gutter X Slope (%)	0.7
N/A	Painted X Walk1?	No	N/A	Painted X Walk2?	No
	X Walk 1 Direction	To N		X Walk 2 Direction	To W
	X Walk 1 Width (in)	N/A		X Walk 2 Width (in)	N/A
	X Walk 1 Slope (%)	5.6		X Walk 2 Slope (%)	3.5
	X Walk 1 X Slope (%)	3.2		X Walk 2 X Slope (%)	4.4

N/A	Ramp inside XWalk1?	N/A	N/A	Ramp inside XWalk2?	N/A
	Road Slope (%)	0.9		Clear Space?	Yes
	Road X Slope (%)	0.2	N/A	Clear Space to XWalk (in)	N/A
Yes	Any Obstructions?	No	Yes	Storm Grate/Utility Hazard?	No
	Obstruction Type			Storm Grate/Utility Type	
		N/A			N/A
			Yes	Surface Condition? (G/P)	Good
			No	Curb Slope (%)	13.3

Remove & Replace Curb Ramp With Two New Directional Ramps or Equivalent.
